NEW COUNTY & CITY LIBRARY KILKENNY - PART 8

75 & 76 JOHN STREET,
KILKENNY,
IRELAND

SECTION A
BUCHOLZ MCEVOY ARCHITECTS
ARCHITECTURAL REPORT

A NEW COUNTY AND CITY LIBRARY FOR KILKENNY

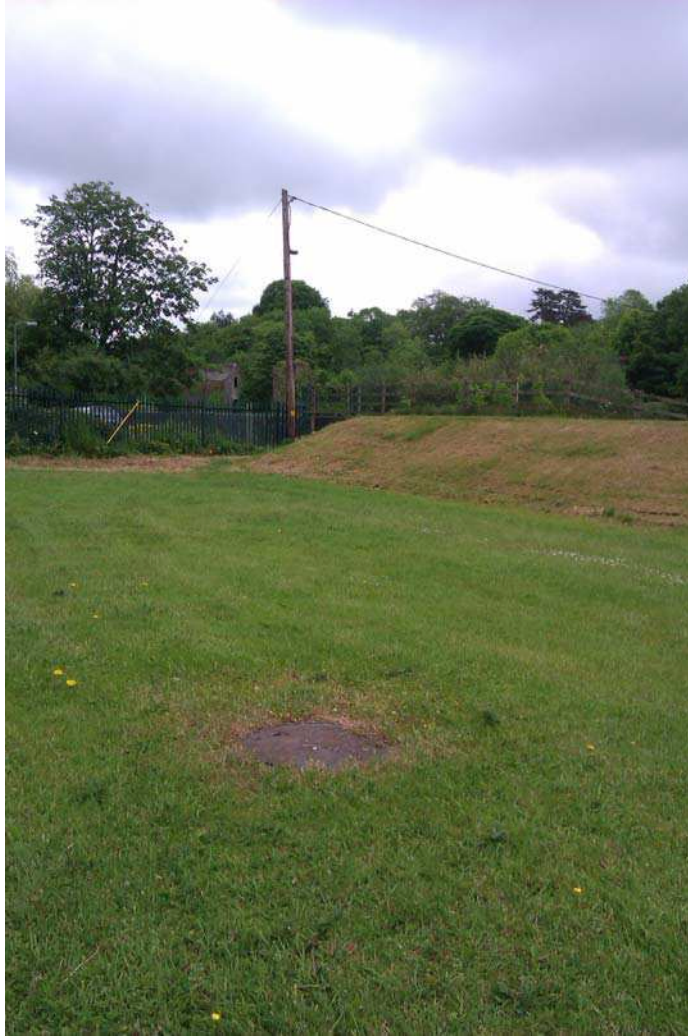
Photograph 3 & 4: Embankment on the Site

The embankment located between the site and the river bank is in a good, well kept condition.

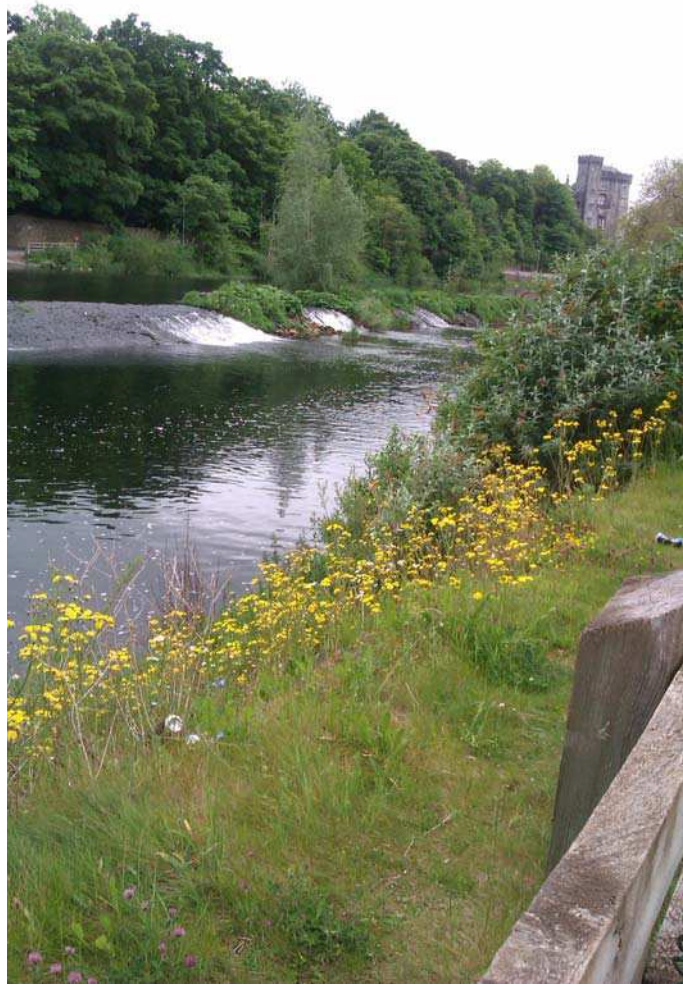
The presence of large debris including branches on the river weir was noted, indicating high water flows during times of flooding.

Photograph 5: Weir in River Nore by Site

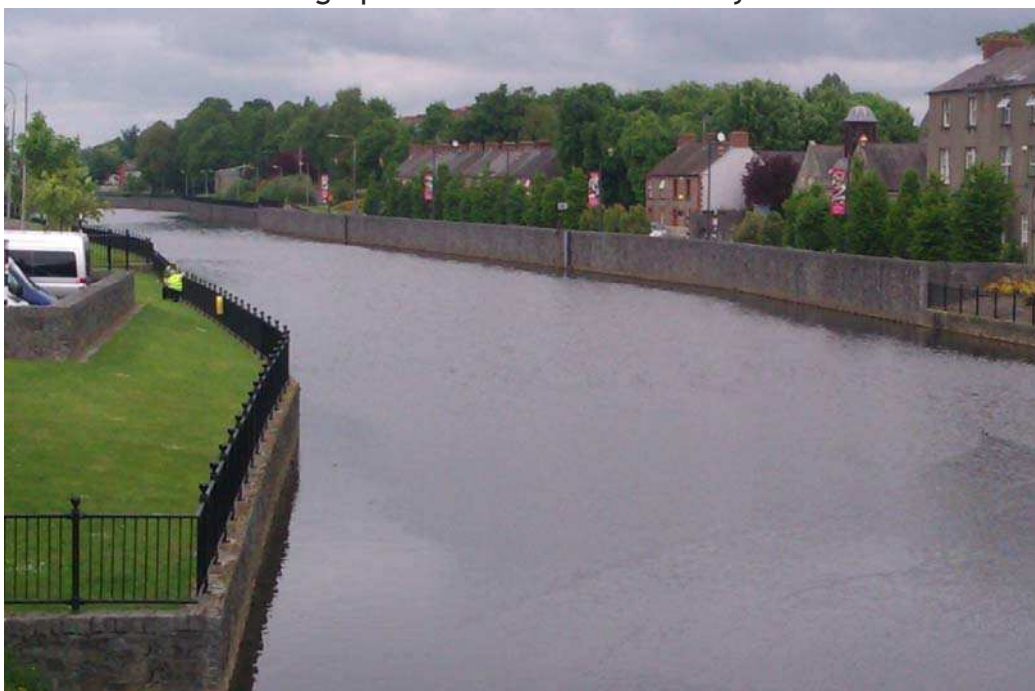
Photograph 6: Flood defences Upstream on the River Nore

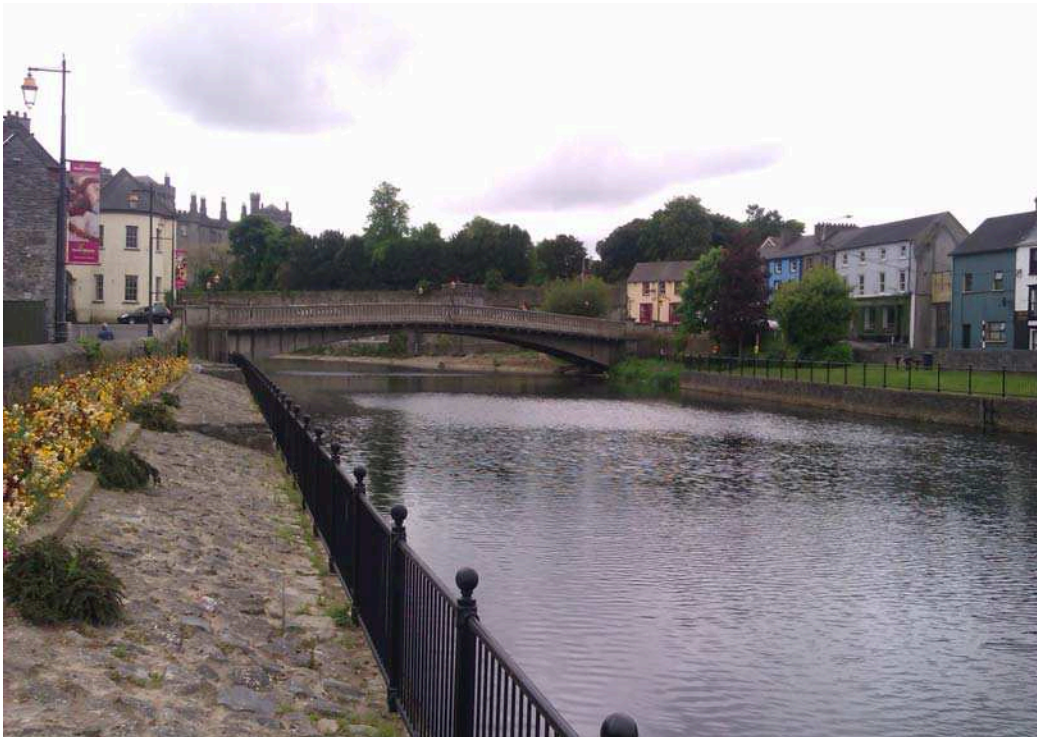
No obstructions were observed under John Street Bridge which would restrict flows in the river.

Photograph 7: Johns Bridge

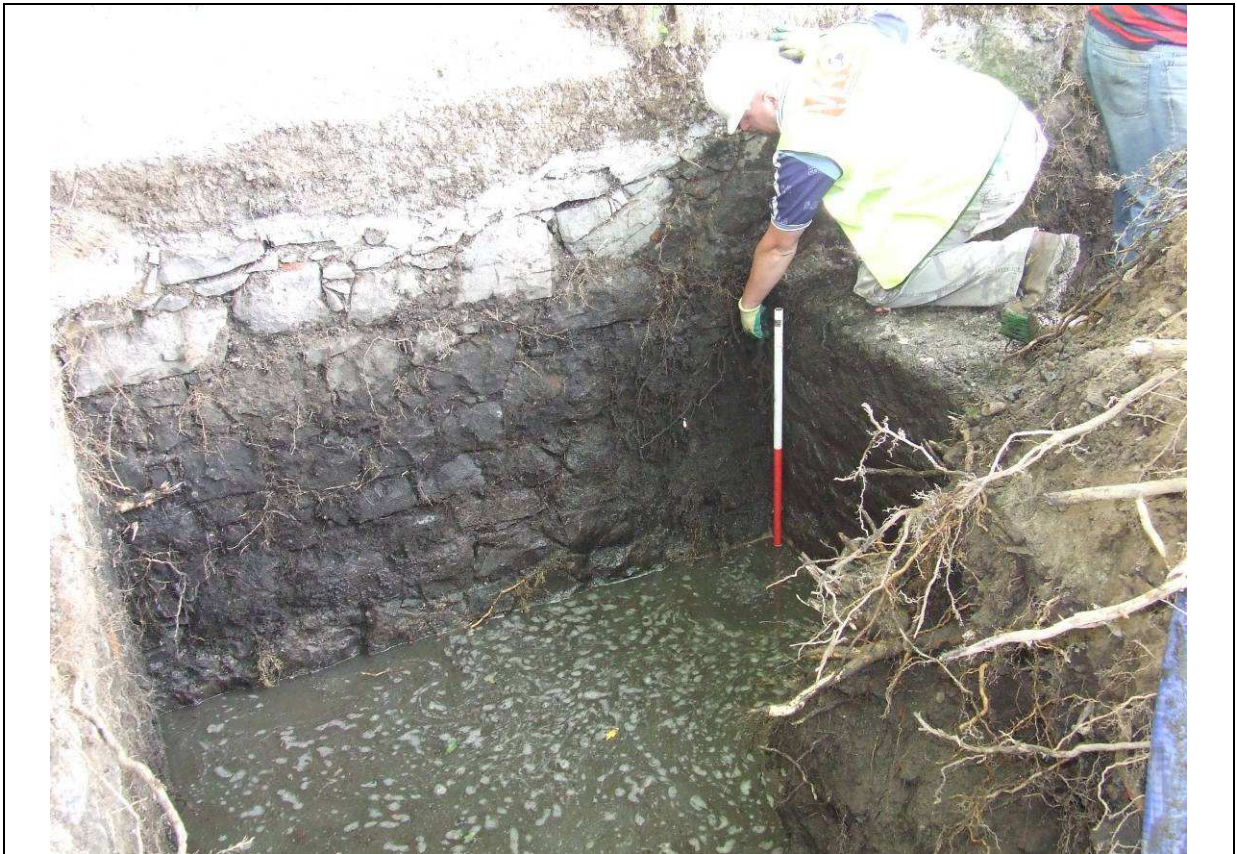
Plate 5: Walls C1 (left) & C15 (right), Trench III, Collegepark townland (Phase 1A), looking northwest.

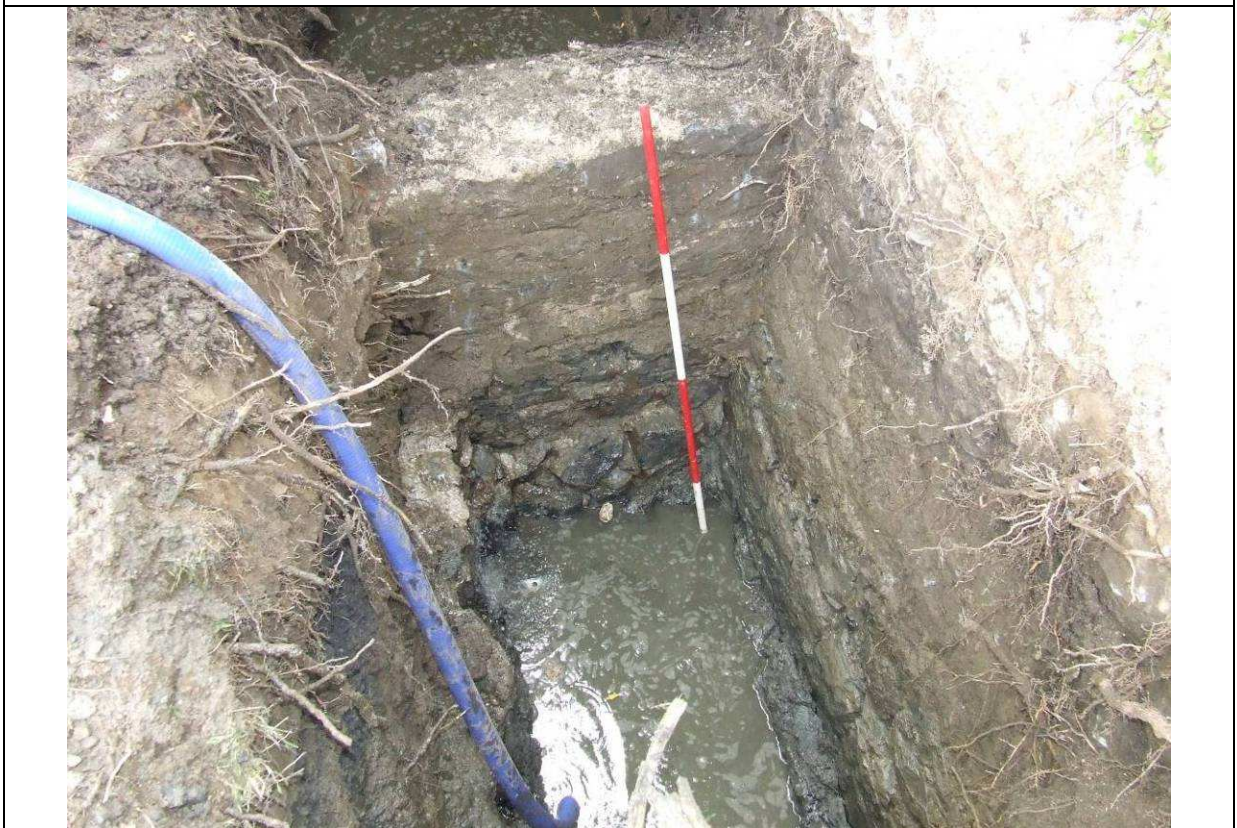
Plate 6: Walls C15 (left) & C1 (right), Trench III, Collegepark townland (Phase 1A), looking southwest.

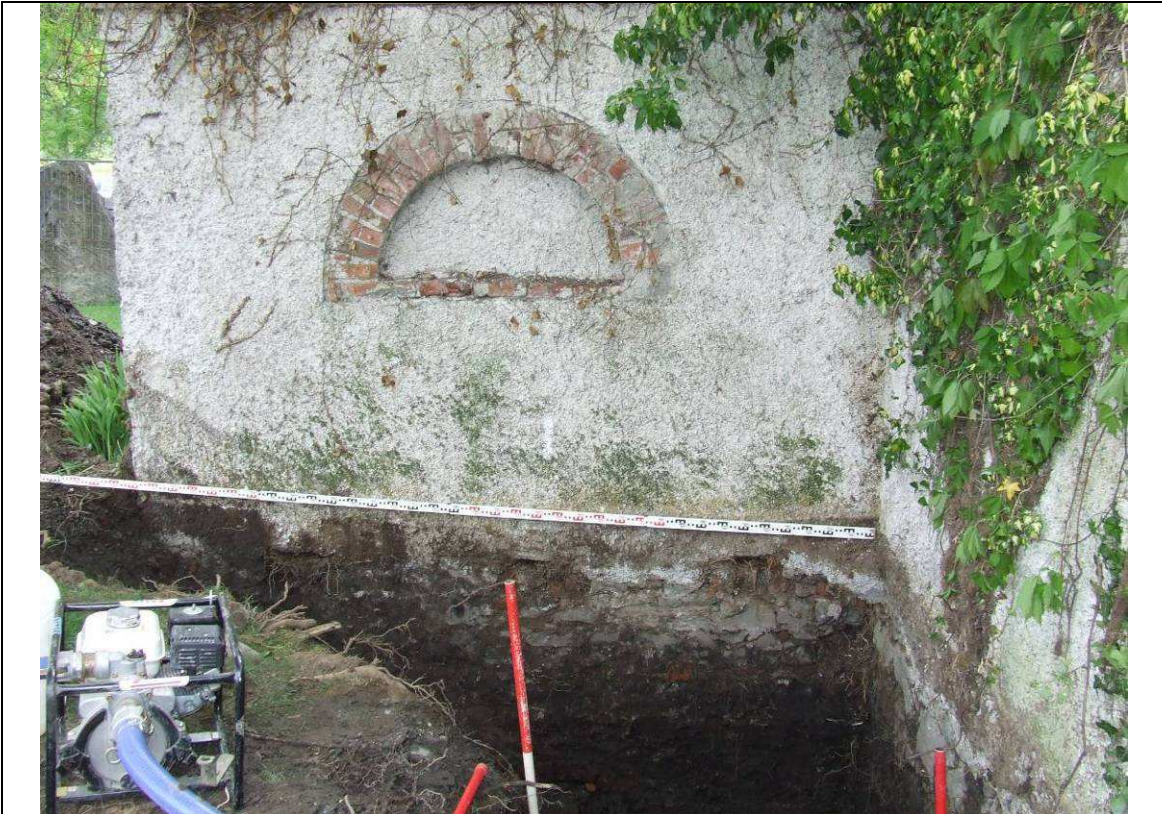
Plate 7: Upper mill wall C2, Trench II, Collegetownland (Phase 1A), looking south.

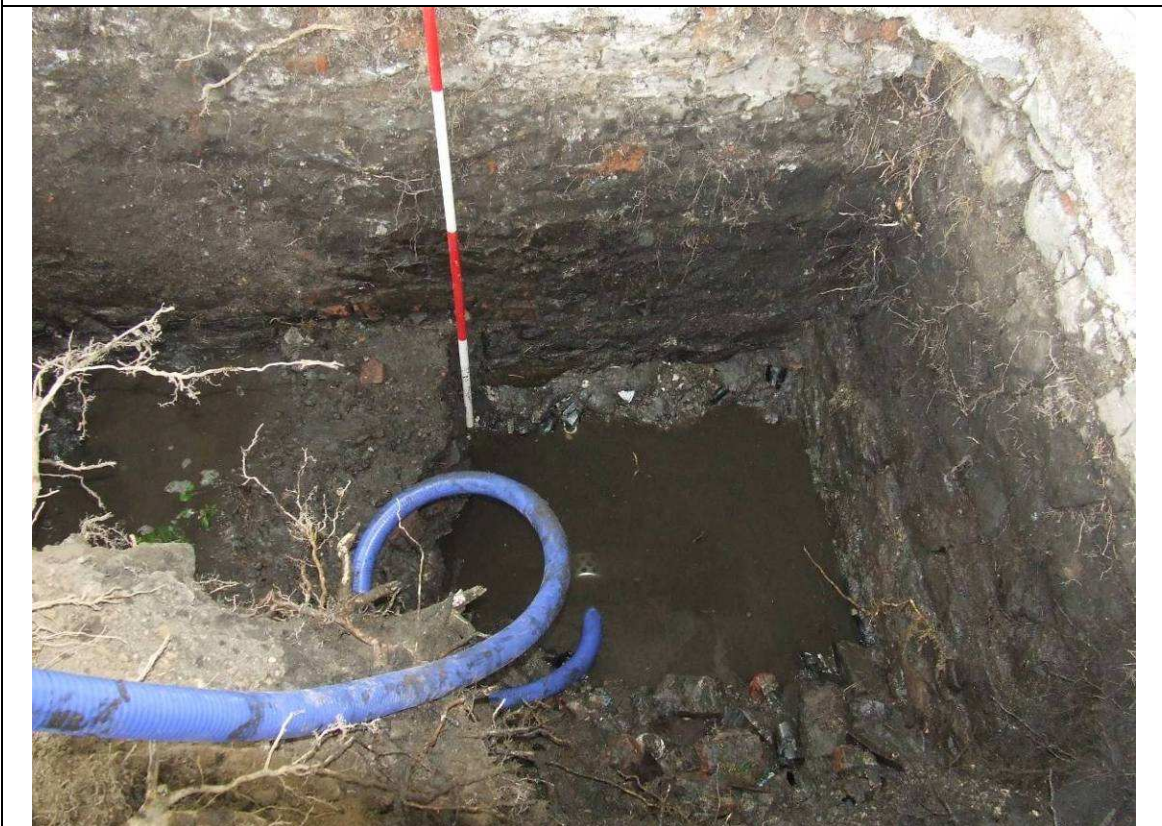
Plate 8: Lower mill wall C2 and sluice. Trench II, Collegetownland (Phase 1A), looking south.

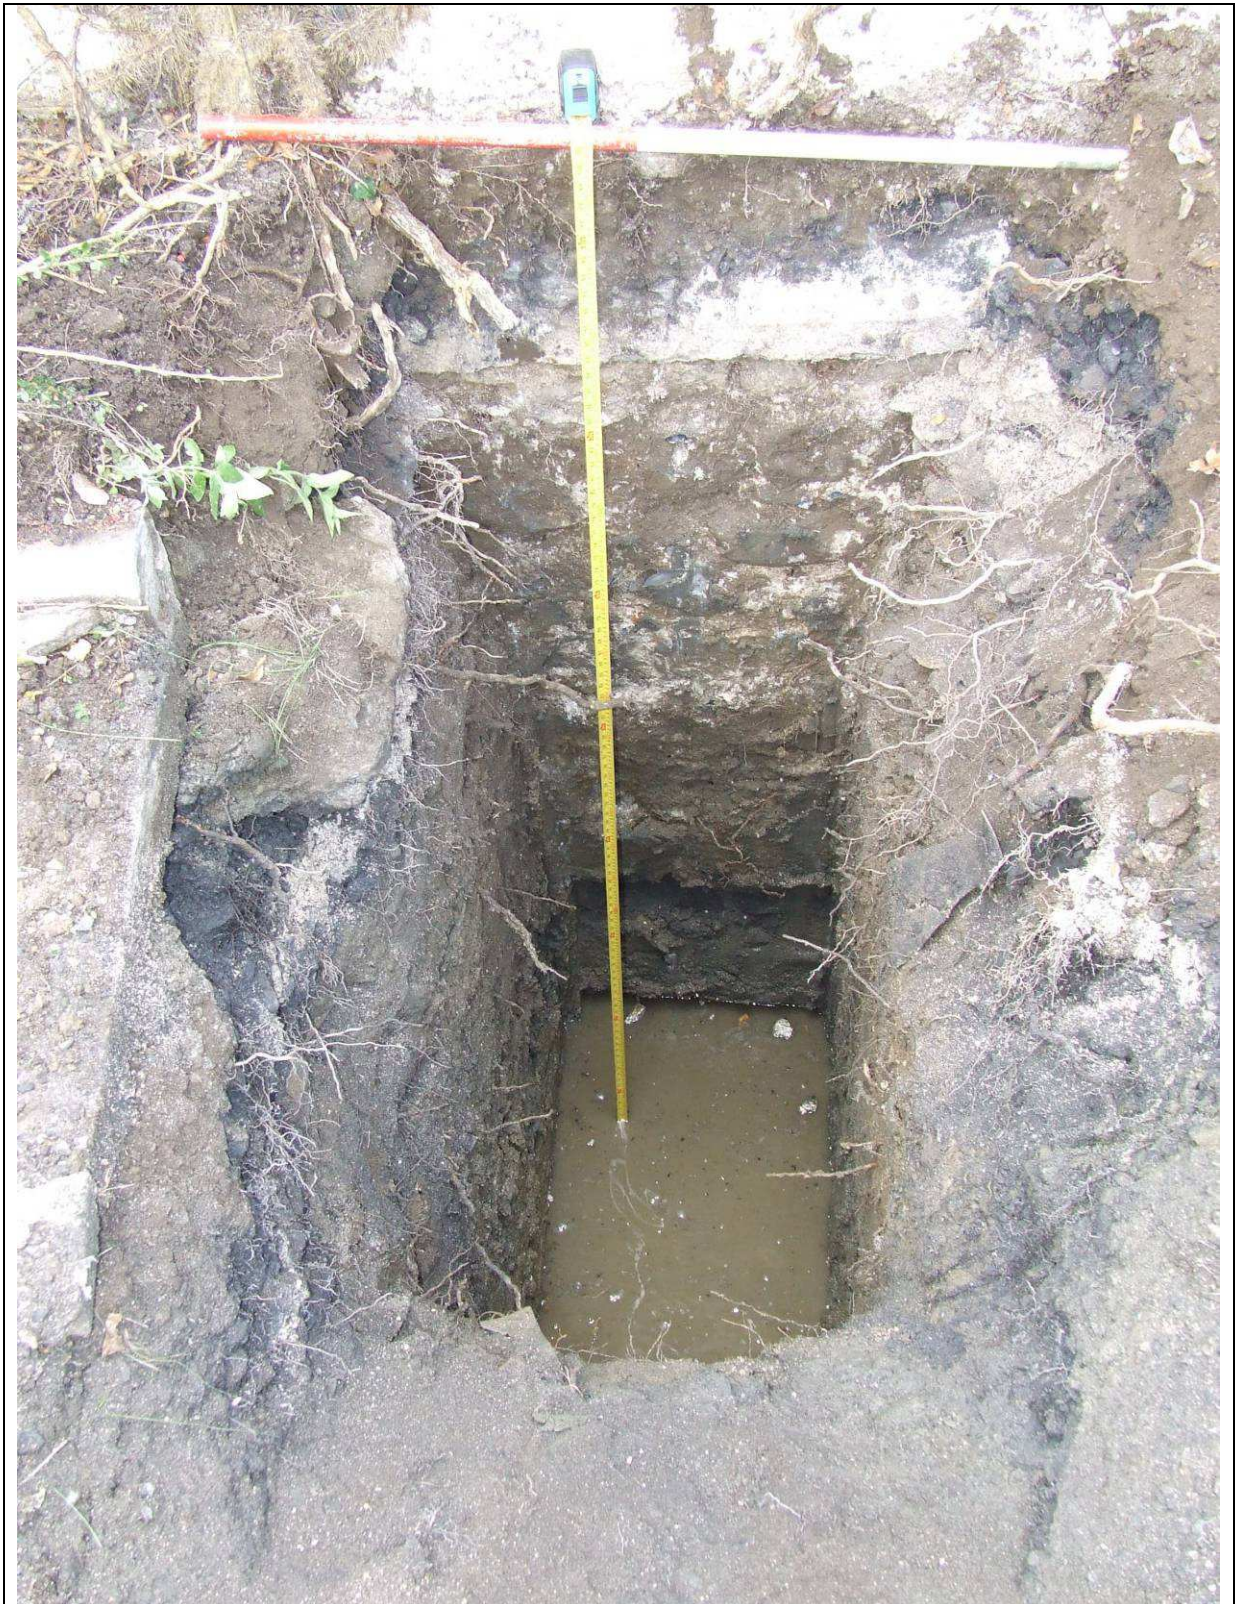
Plate 9: Boundary wall C20, and garden soil C22. Trench IV, Collegepark townland (Phase 1B), looking southeast.

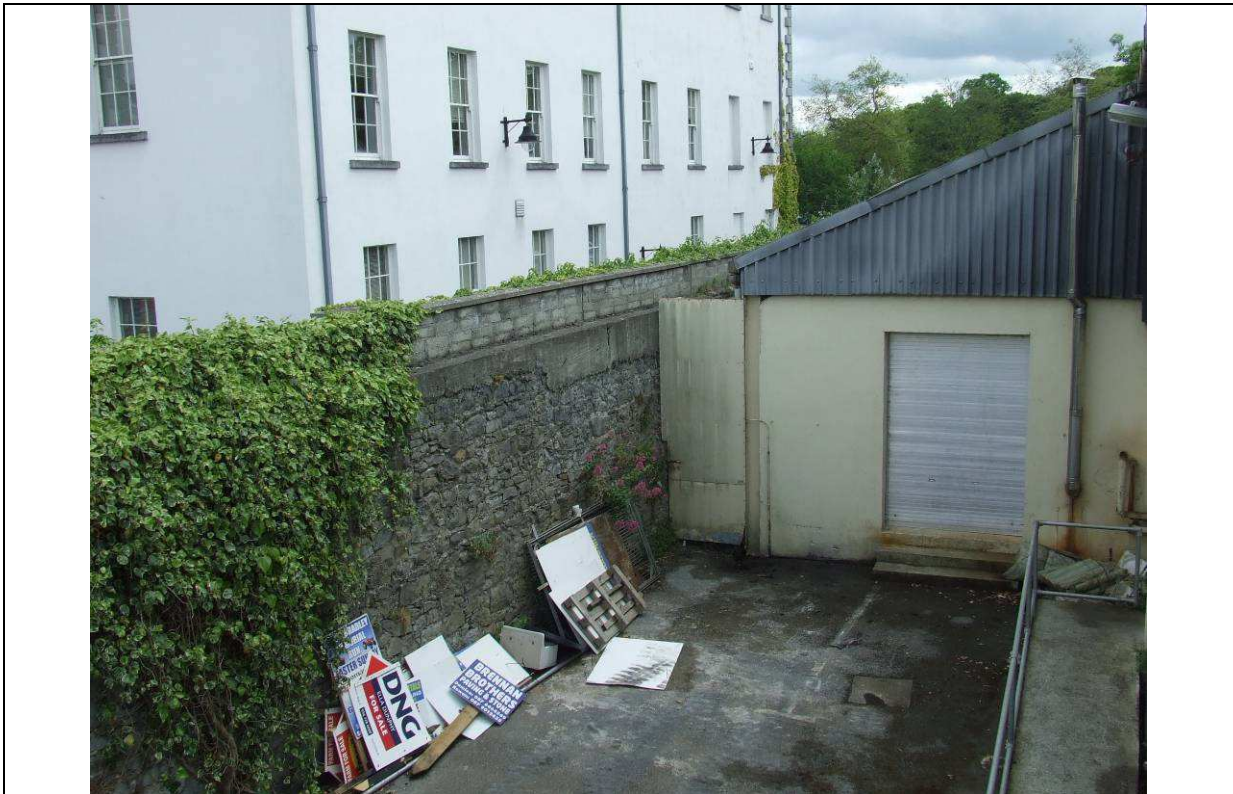
Plate 10: Boundary wall C20, view from rear no. 76 John Street Lower (Gardens townland), looking east.

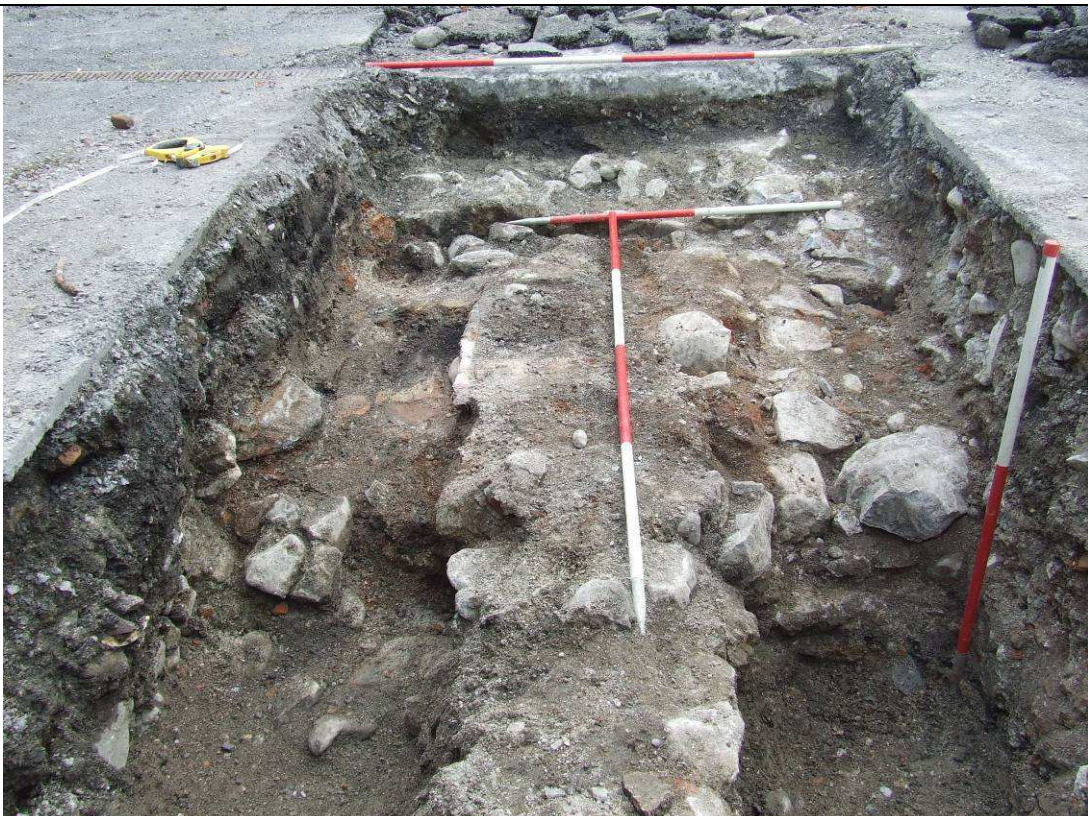
Plate 13: Trench V (southern extent), showing internal walls C32, C34 & C40. No. 75 John Street Lower, Gardens townland (Phase 1B), looking southwest.

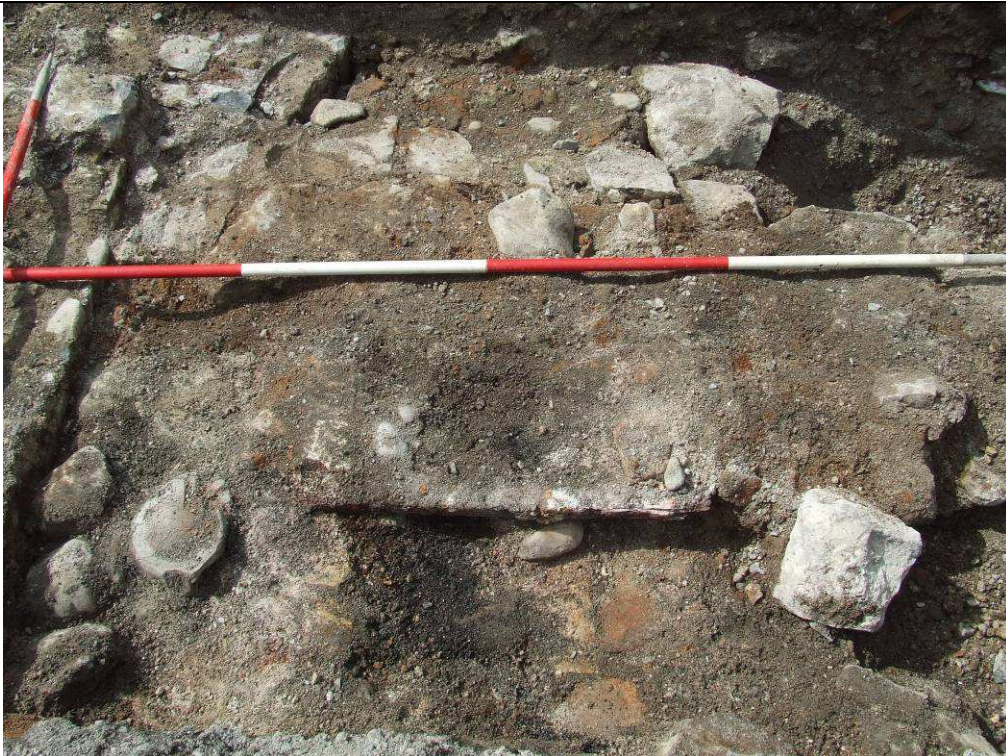
Plate 14: Trench V (southern extent), showing fireplace and iron grate C36/C37 & masonry features C38 & C35. No. 75 John Street Lower, Gardens townland (Phase 1B), looking southwest.

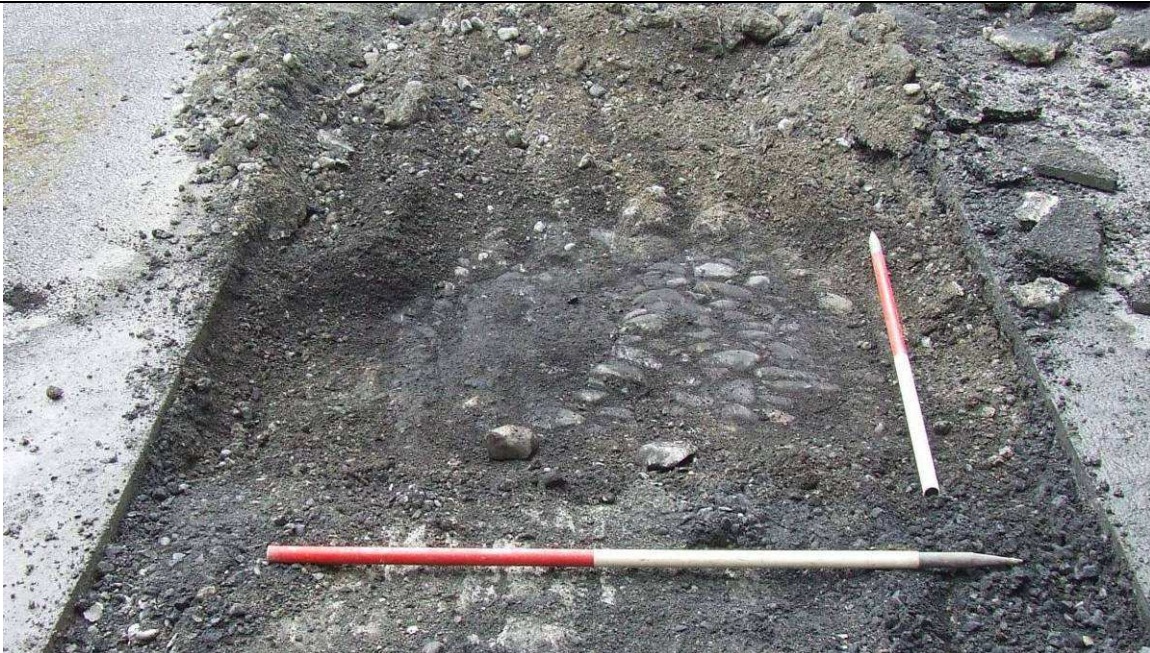
Plate 16: Trench VI (west), showing post-medieval cobbles surface C48. No. 76 John Street Lower (Gardens townland), looking southeast.

This trench was located within the northwestern extent of the development site, 1m southeast of the rear walls and arch of no.s 75 & 76 John Street Lower. The trench measured 25m in length (orientated northwest / southeast), 1.5m in width and up to 1.7m in depth. (See Figures 2, 8, 10; Plates 15–19)

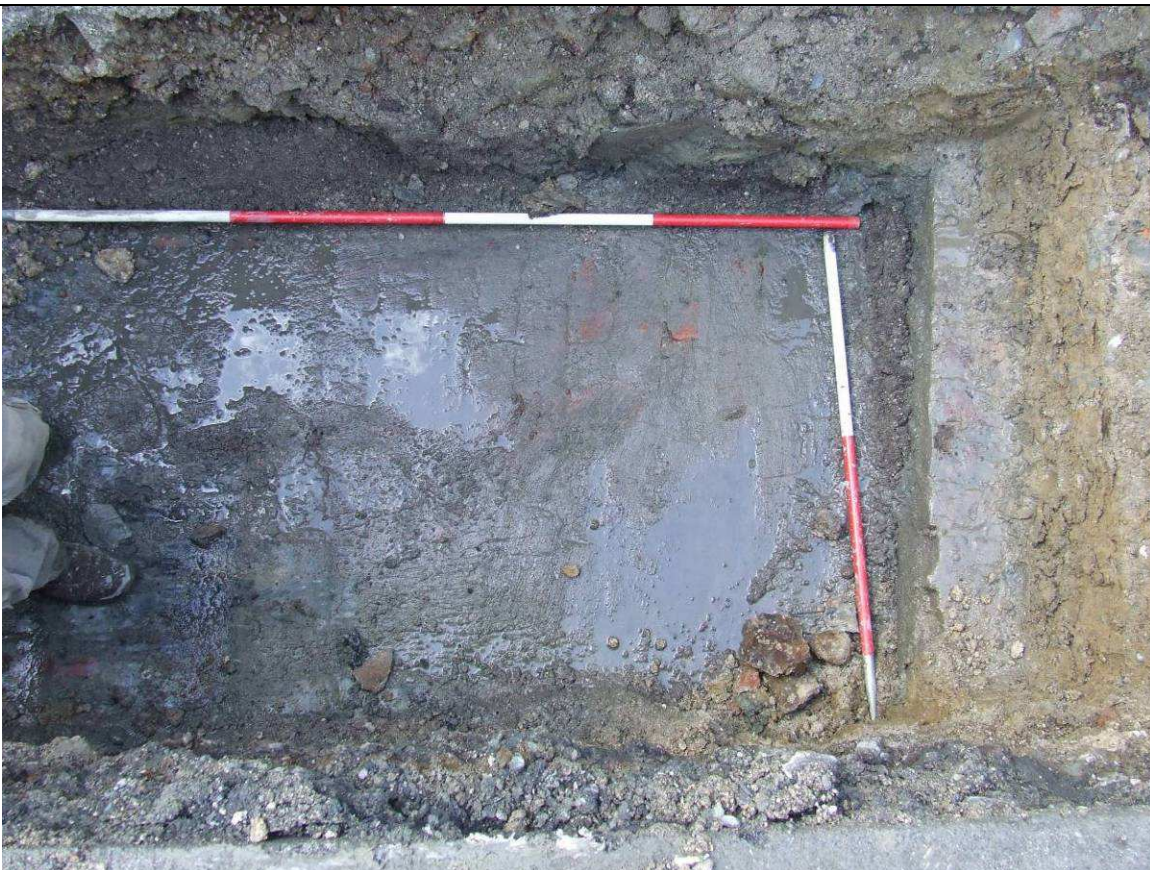
Plate 17: Trench VI (west), showing cellar floor C51. looking southwest.

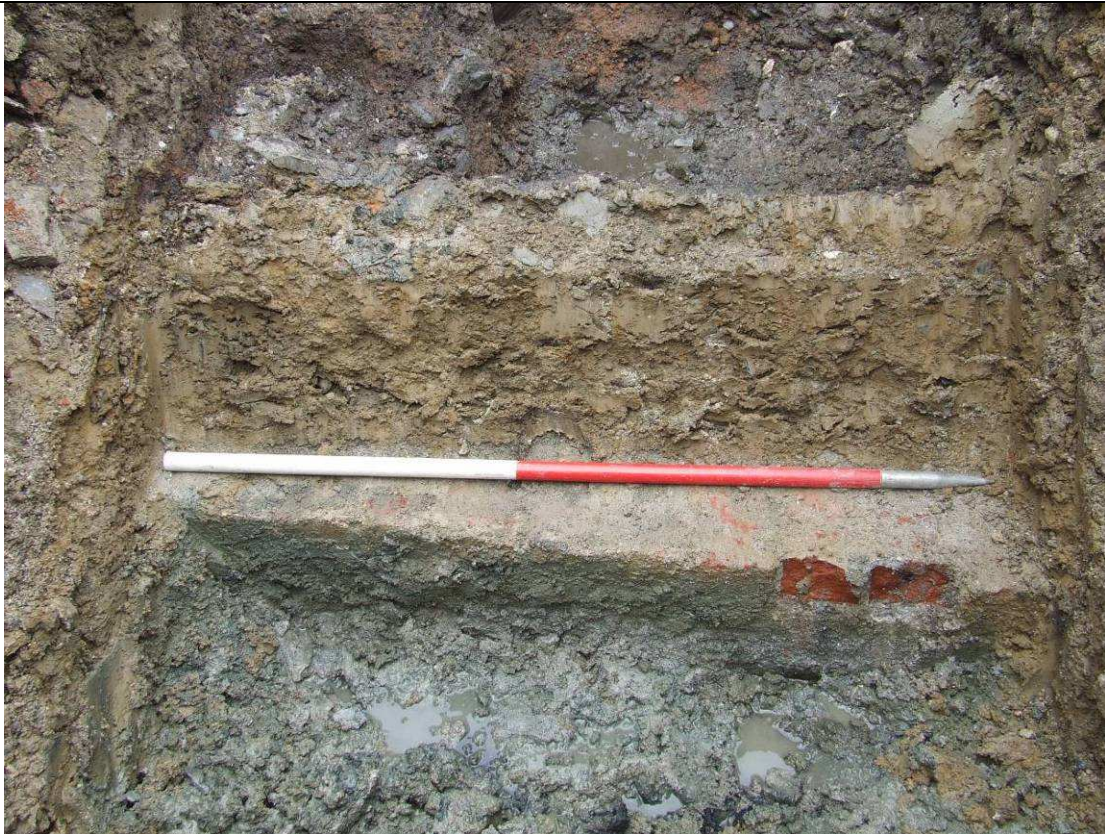
Plate 18: Trench VI (west), showing cellar ledge C51 cutting features C54 & C55, looking northeast.

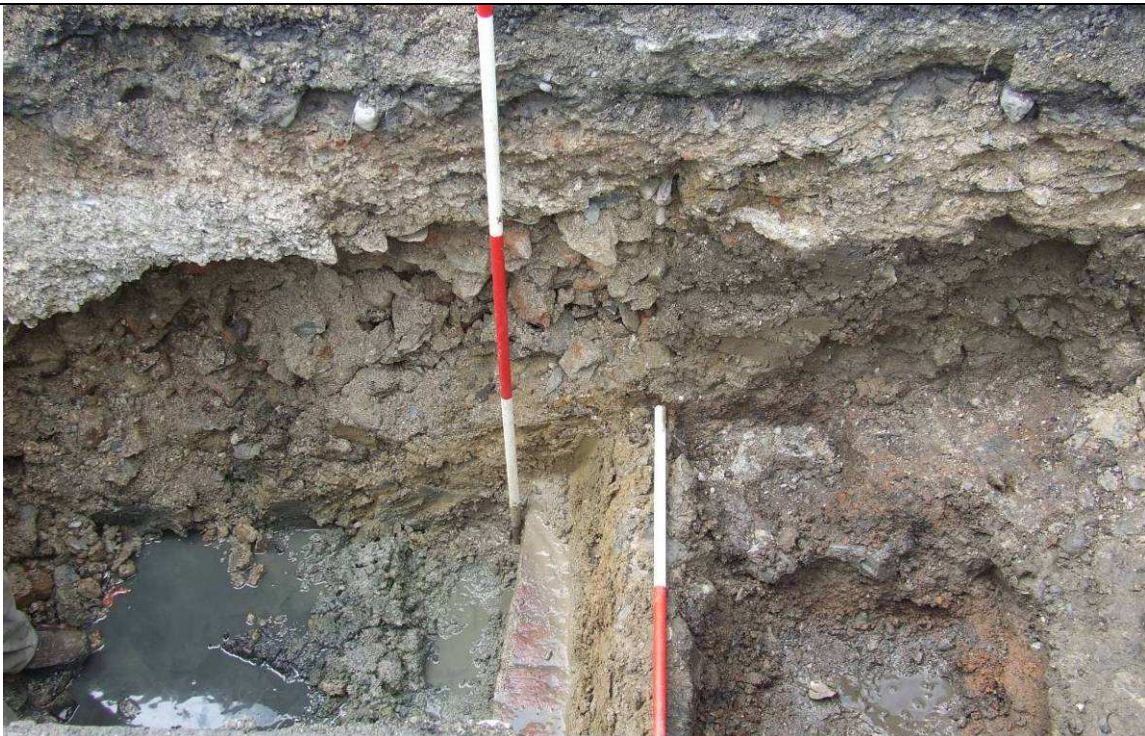
Plate 19: Trench VI (west), showing cellar ledge C51 cutting reclamation deposit C53, medieval ash/hearth features C54, looking northeast.

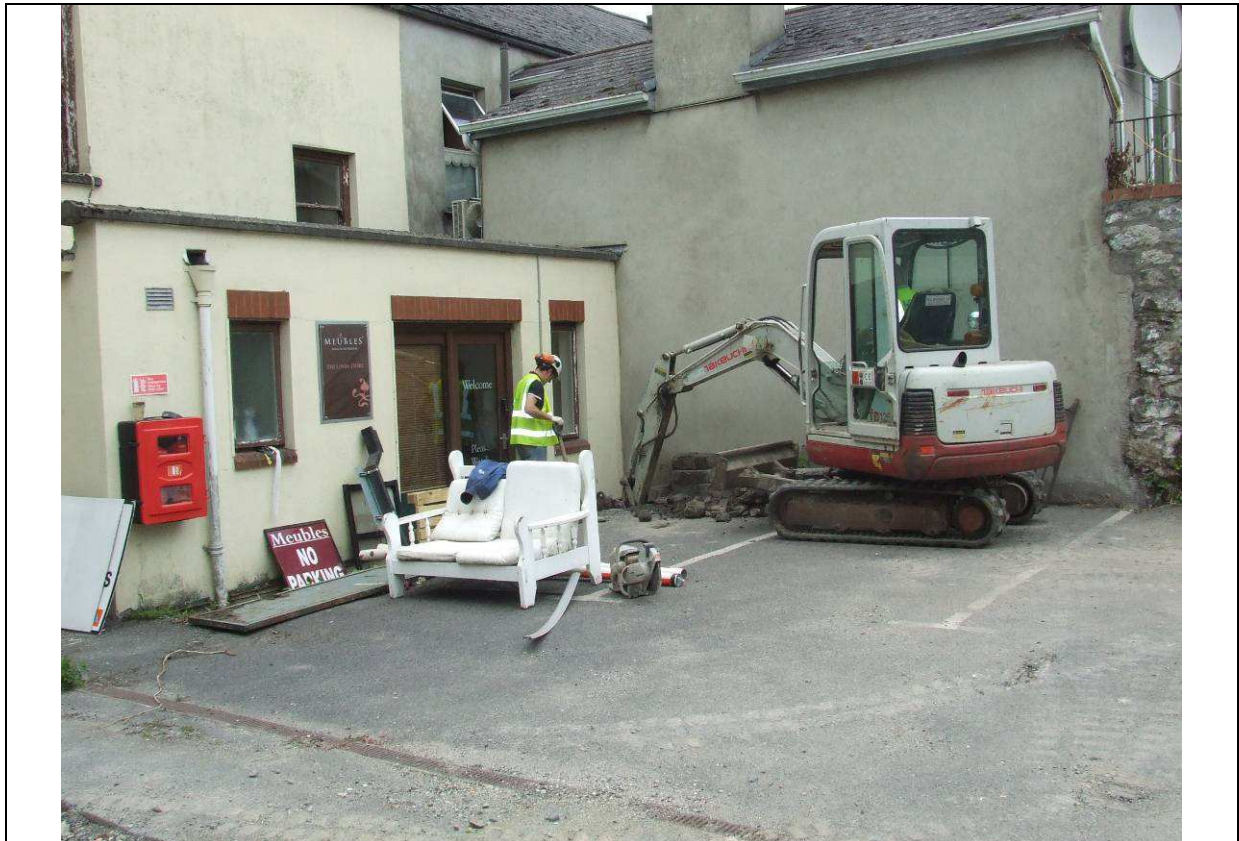
Plate 20: Trial Pit 1, under excavation, looking northwest.

This trial pit was one of two (Trial Pits 1 & 2) located in the townland of Gardens (St John's Parish), to the rear yard of No. 75–6, John Street Lower (See Figure 8).

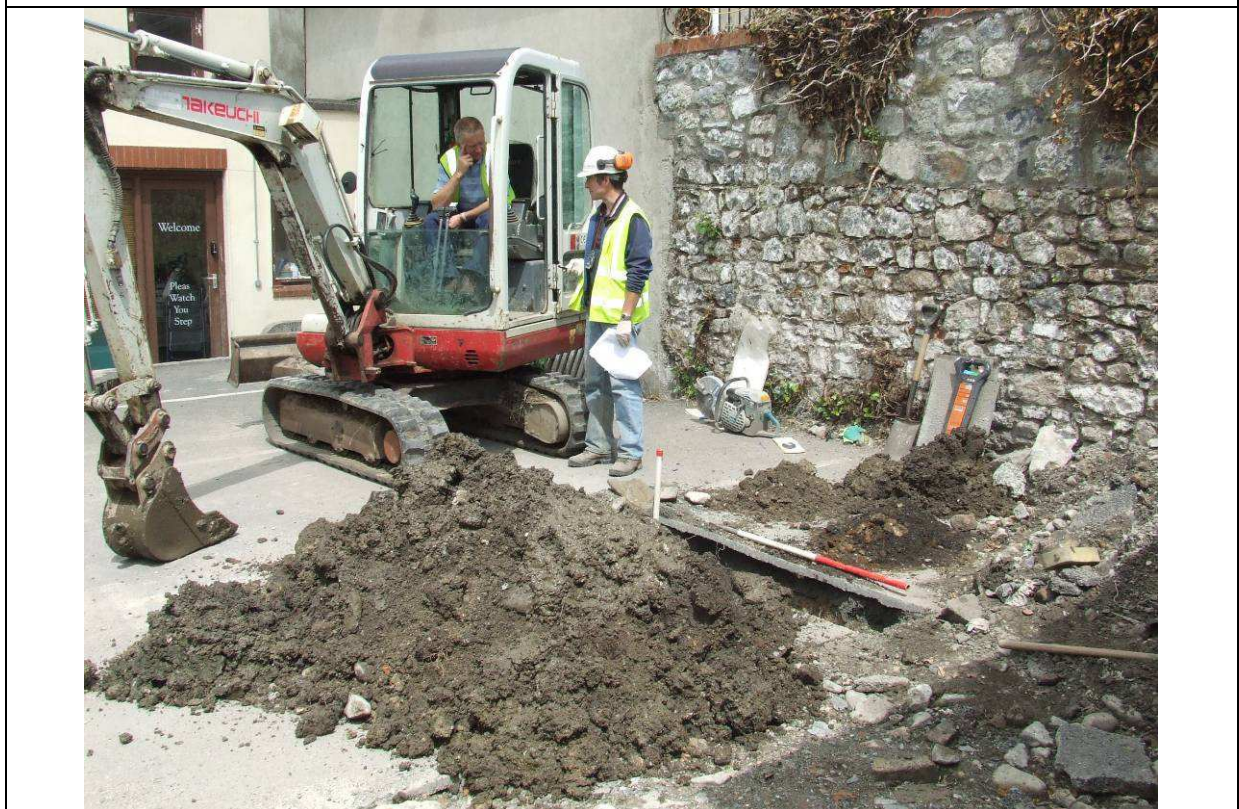
Plate 21: Trial Pit 2, under excavation, looking northwest.

This was the second trial pit of two (Trial Pits 1 & 2) and was also located in the townland of Gardens (St John's Parish), to the rear yard of No. 75–6, John Street Lower (See Figure 8).

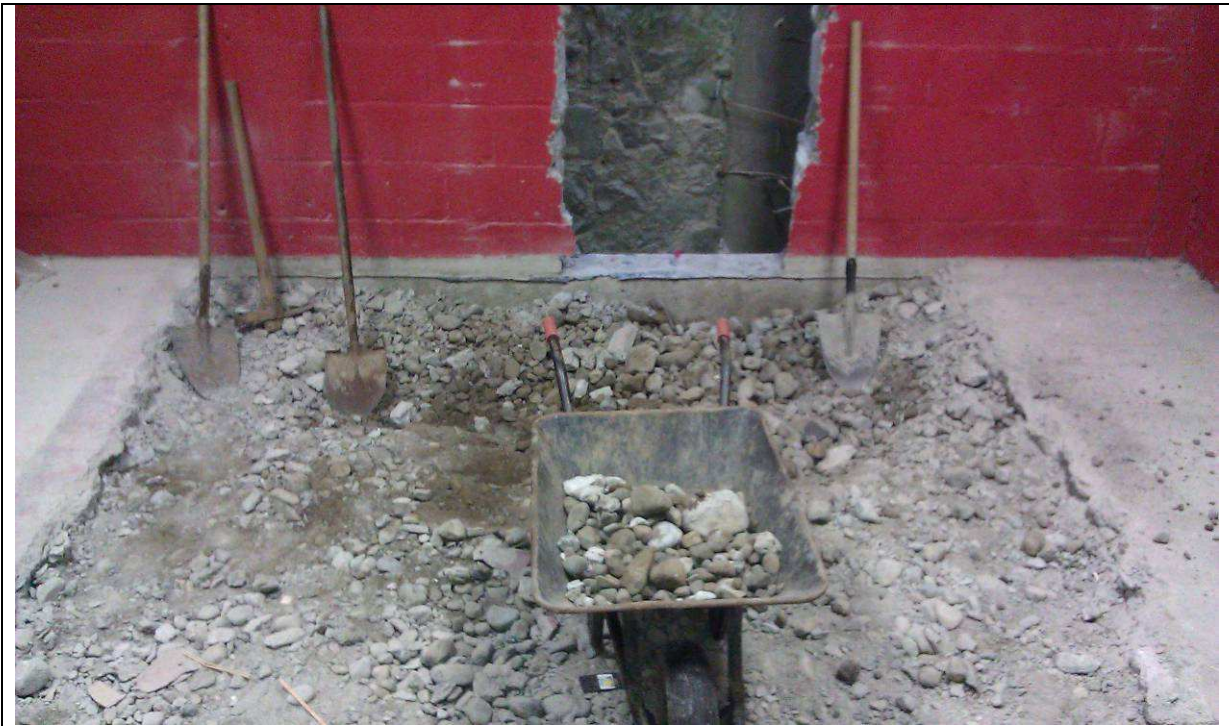
Plate 5: Trench VII showing initial removal of concrete floor and new opening in block wall. Looking southeast.

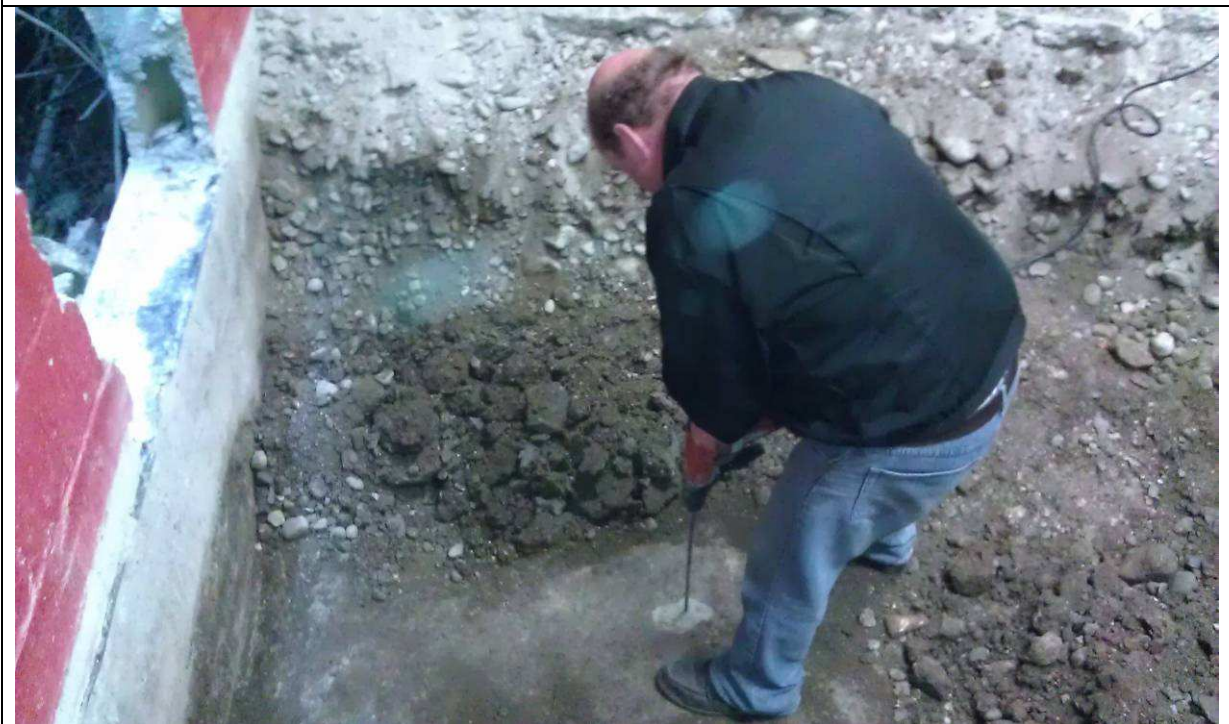
Plate 6: Trench VII in progress showing 1m of modern overburden over 2nd concrete floor. Looking south.

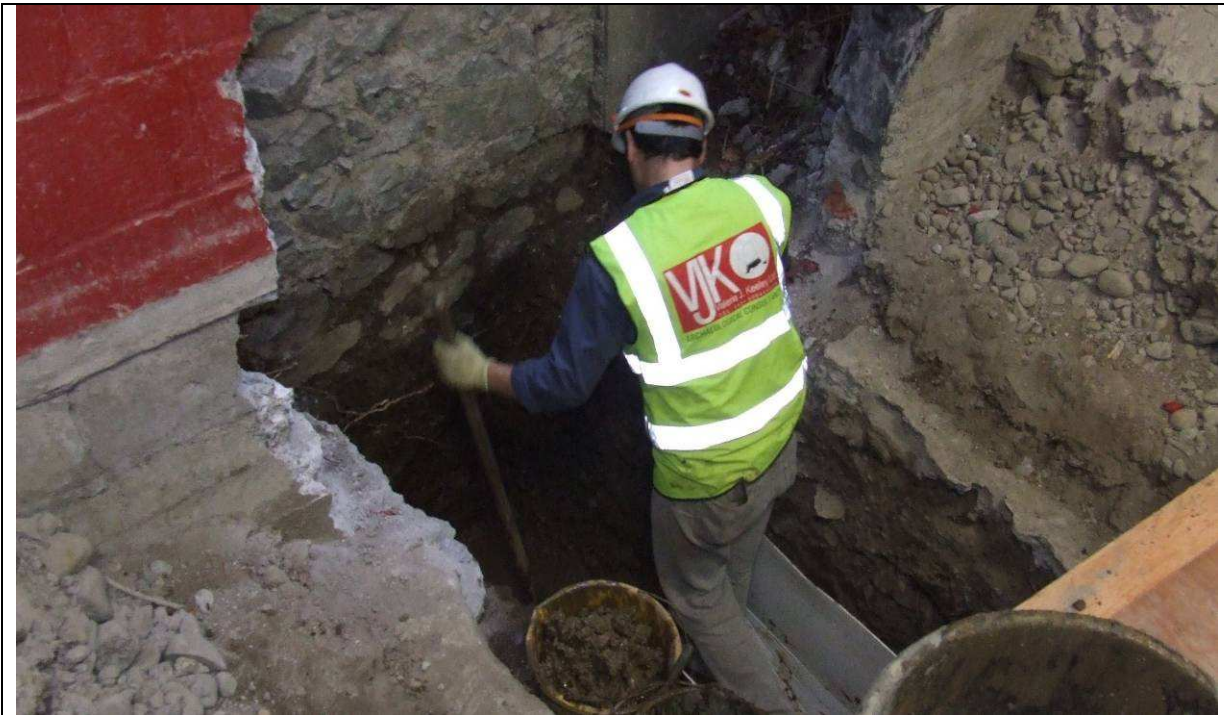
Plate 7: Trench VII following removal of 2nd floor and concrete ring-beam under block wall C60. Looking south.

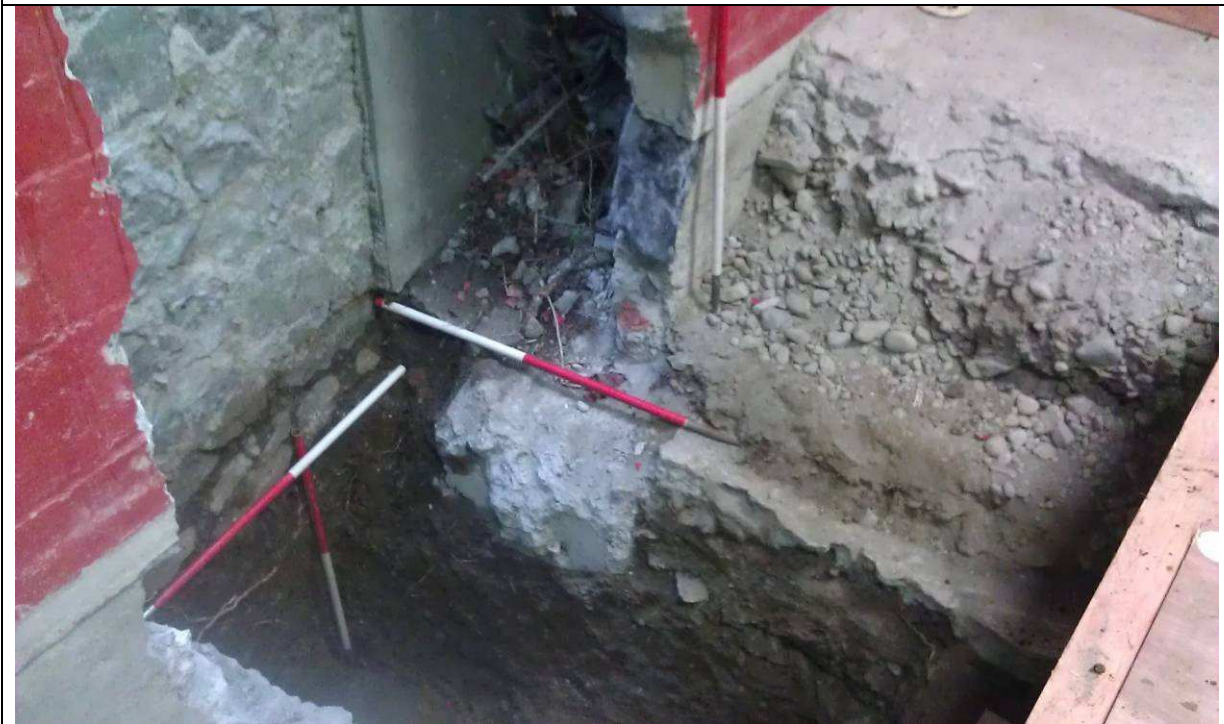
Plate 8: Trench VII, showing masonry wall C01, modern wall & ring-beam C60, floors and overburden C58/C59, post-medieval deposits (C62, C63 & C64). Looking south.

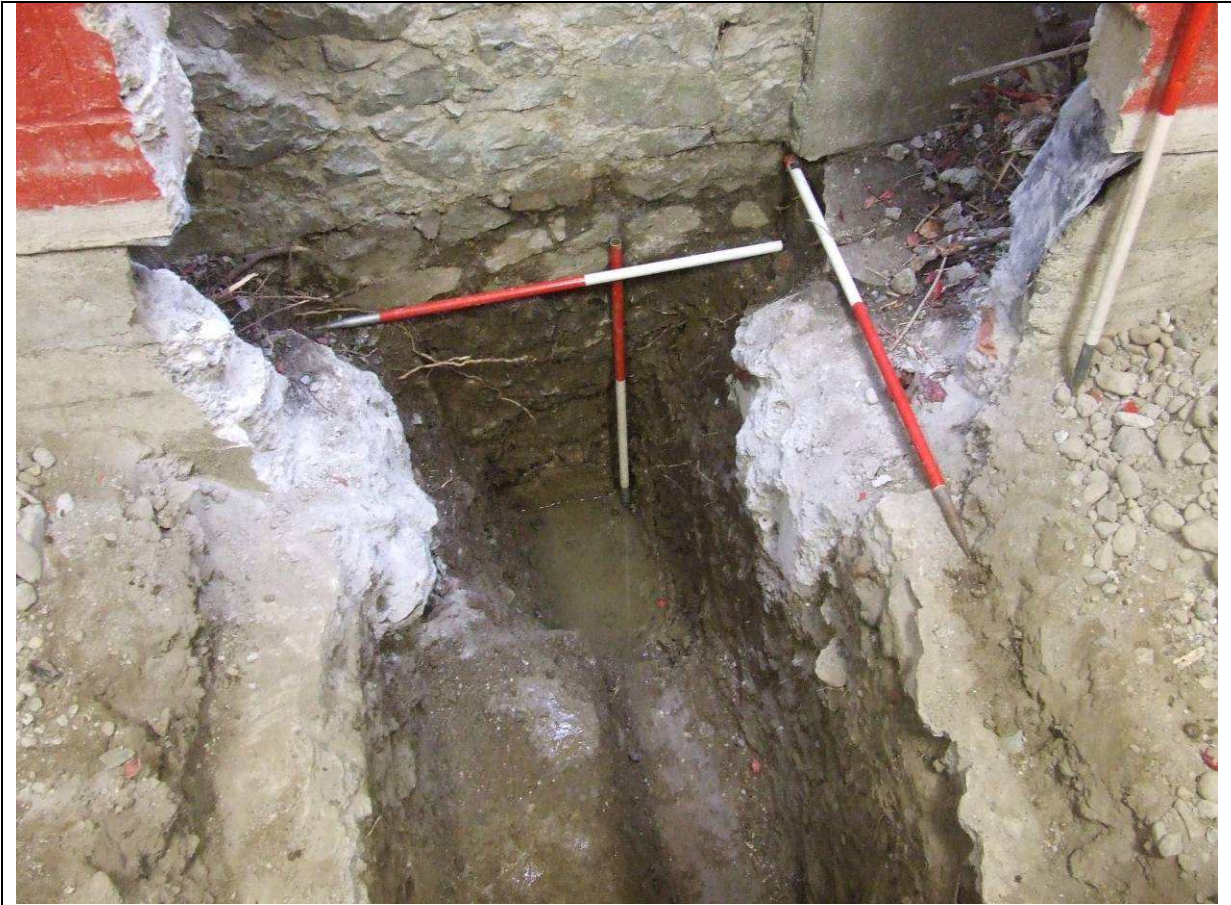
Plate 9: Trench VII, showing water-table, lower masonry wall C01, and archaeological deposits C65 (mortar) C66 (sticky clay) and C67 (fluvial clay), looking south.

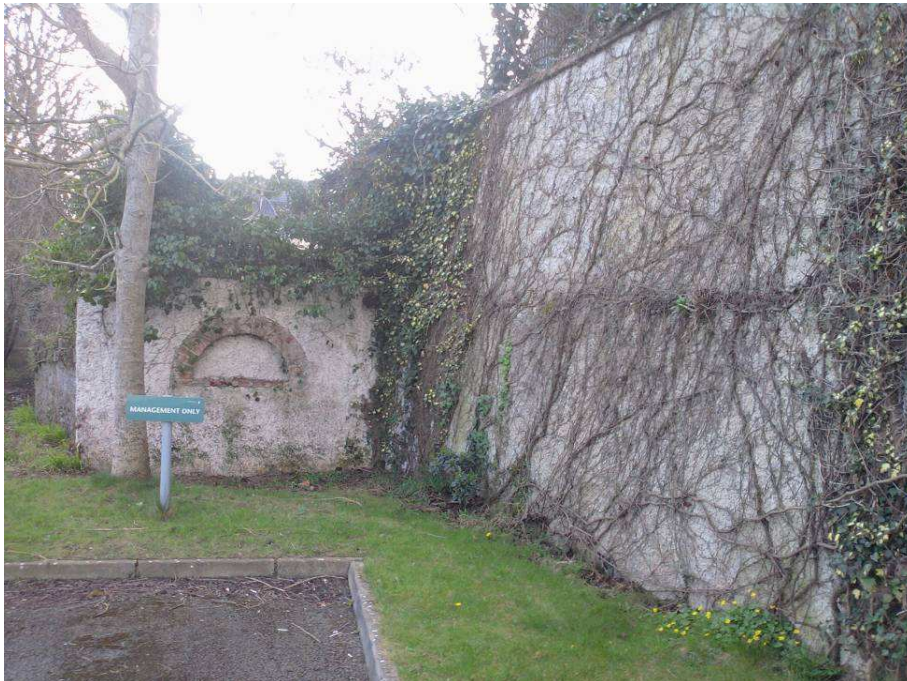
Plate 1: View south, masonry wall C01 (right) abutted by remains of 19th century mill.
