NEW COUNTY & CITY LIBRARY KILKENNY - PART 8

75 & 76 JOHN STREET,
KILKENNY,
IRELAND

SECTION A
BUCHOLZ MCEVOY ARCHITECTS
ARCHITECTURAL REPORT

A NEW COUNTY AND CITY LIBRARY FOR KILKENNY

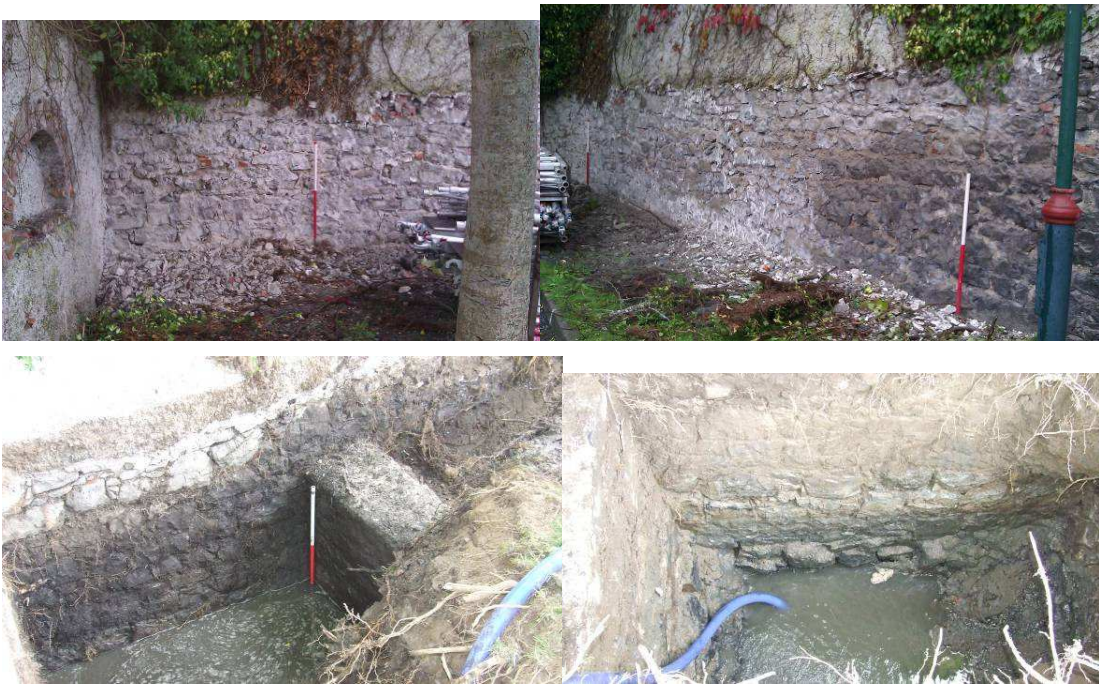
Plate 7: Composite views of masonry wall looking west, with plaster removed and under excavation.

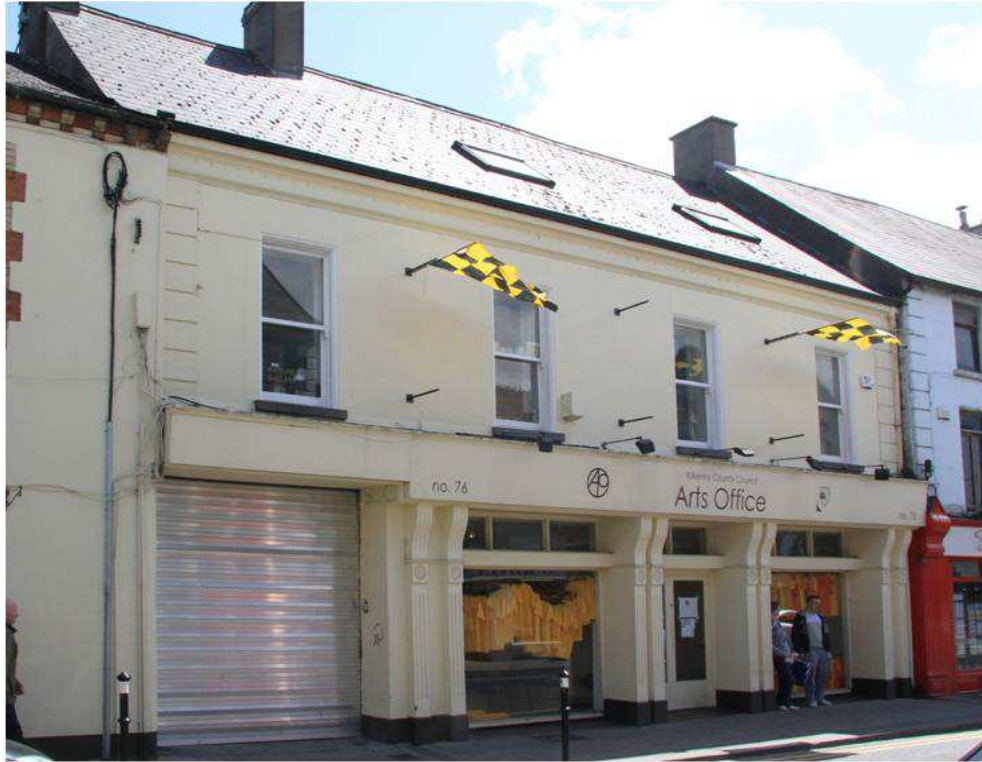
Number 76 is two-storey and four-bay, with a shopfront of relatively recent date across three bays, having paired pilasters surmounted by brackets supporting a fascia board that runs the full width of the facade. The entrance is in the centre of the shopfront. The fourth bay, on the left-hand side, is a vehicular entrance leading to the rear. The access to the rear is enclosed by a roller steel shutter that has been fitted recently.

The facade on the upper floor is rendered, ruled, lined and painted, with parallel quoins in plaster and with a projecting moulding at the eaves. The windows are one-over-one timber sliding sashes with curled horns set over sills of unpainted cut limestone. The roof is single pile with fibre cement slates. There are two rooflights of relatively late date in the front slope of the roof. There are chimney stacks at the party walls and over the divide between the access arch and the main building and these are rendered.

An ogee-profile cast iron gutter runs along the eave to a downpipe at the right-hand end of the facade.

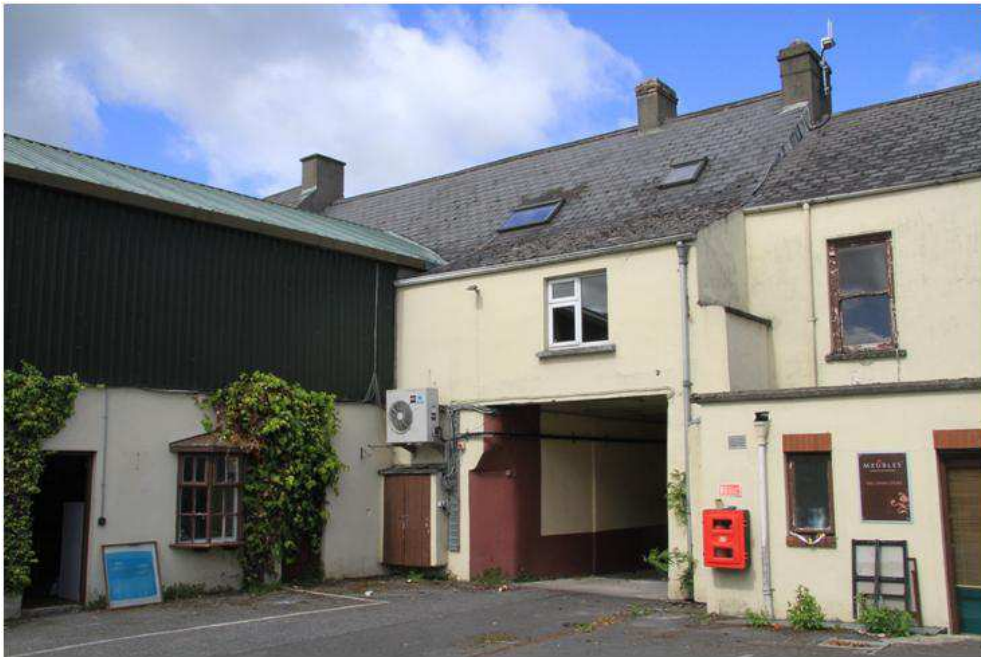
Plate 4: Rear of number 76

Plate 4 above shows the projecting upper floor at the rear of number 76. It also shows that there is a pier of masonry adjacent to this projection on the party wall with number 75. The chamfer in the wall at the corner of the rear access is visible in this photograph.

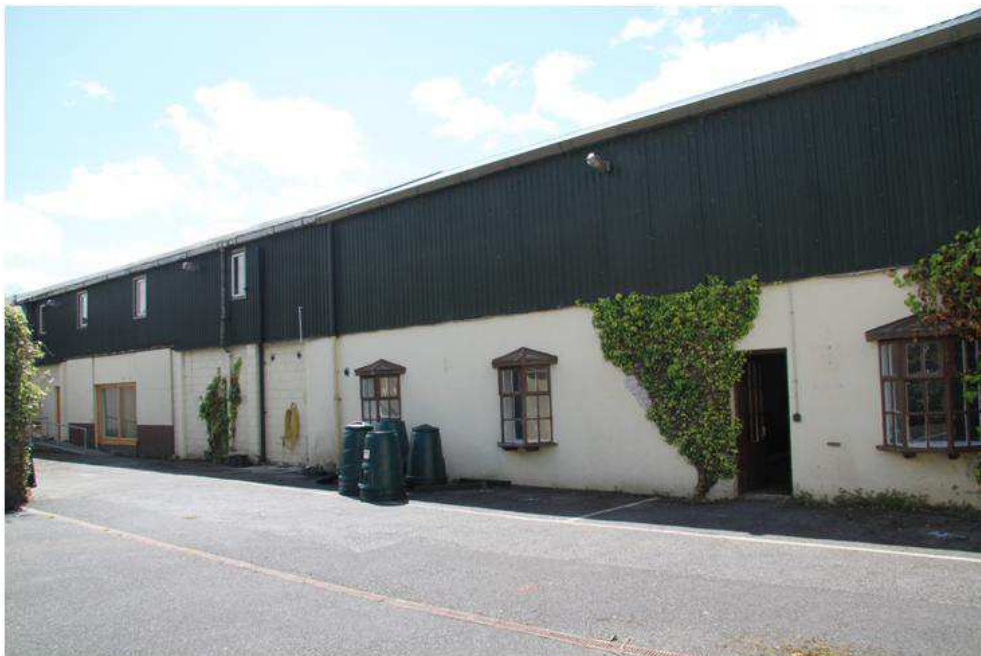
Plate 5: Return at rear of number 76

There is a substantial return at the rear of number 76. The roof and upper floor are clad in profiled steel and the ground floor walls are of concrete. It would appear to have been built in at least two phases, as the section close to the main building is rendered, while to the rear of this painted concrete block is visible.

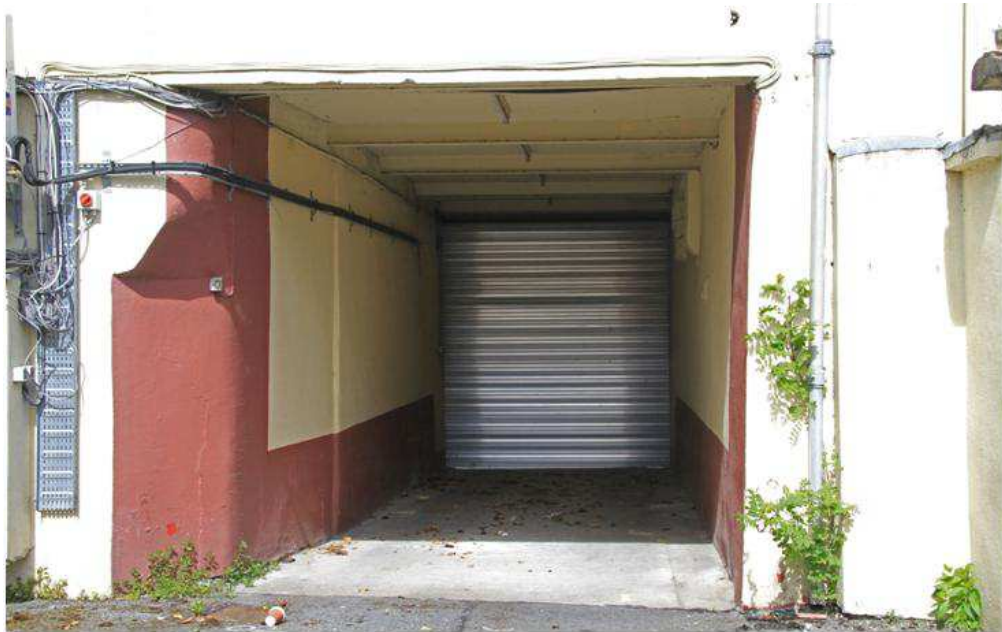
Plate 6: Access from street

The access from the street runs through number 76, with the upper floor oversailing. There is a slight change in the face of the wall to the left, reflecting the position of the extension at the rear of number 76. The upper floor is supported on steel joists. On the right-hand wall, near the top, there is the base of a disused fireplace. This was plastered over at some point, but the general shape may be distinguished. On the left-hand side the plaster has detached, revealing the stonework below. This shows that the fireplace is supported on roughly shaped limestone blocks, while the supported masonry is dressed, with a plinth, above which the inner margin is chamfered. Between the fireplace and the rear wall there is a single projecting stone, roughly shaped.

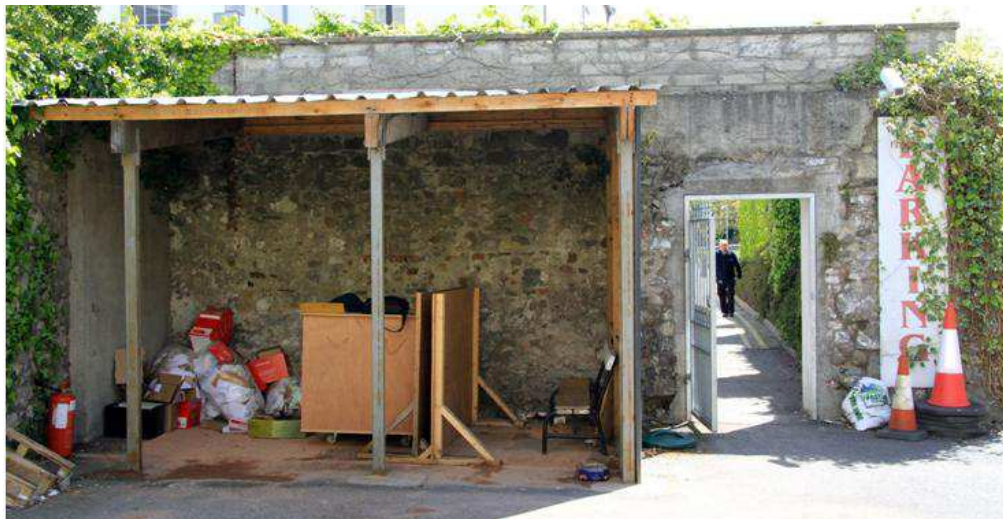
Plate 8: Rear boundary wall of number 75 John Street Lower

At the rear of number 75 there is a boundary wall with a pedestrian gate leading to the grounds of County Hall. This wall has been altered over the years, with concrete blockwork at the top and concrete over and around the gateway. There is brick to the right of the gateway. The main mass of the wall within the shed is rubble stone, with a significant amount of brick fragments, including a line of brick in one small area.

At the rear the proposed library building would replace an existing building, albeit on a larger scale. The principal elements that would stand to be affected by the proposal would be the protected structures, and the potential impacts on those have been addressed above. The other intervention that would have a potential impact would be the removal of the boundary wall between number 76 John Street and the grounds of County Hall. As was noted in the building survey above, this wall is a mix of stone and concrete, with some elements of brick.

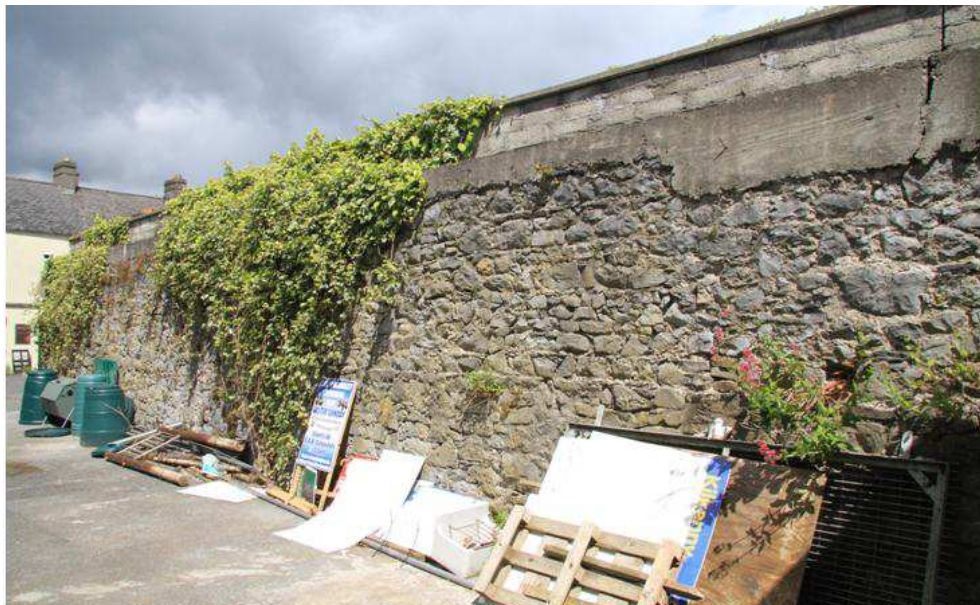
Plate 9: North-eastern side boundary wall of number 76

The boundary wall to the side of number 76 is also of limestone rubble, topped with concrete blockwork on a layer of mass concrete. The stonework of the wall has some horizontal coursing and occasional pieces of broken brick. There are signs of repair or reconstruction in places, one of which may be seen at right in the photograph where the small stonework with a horizontal emphasis gives way to larger stones with a less obvious horizontal orientation.

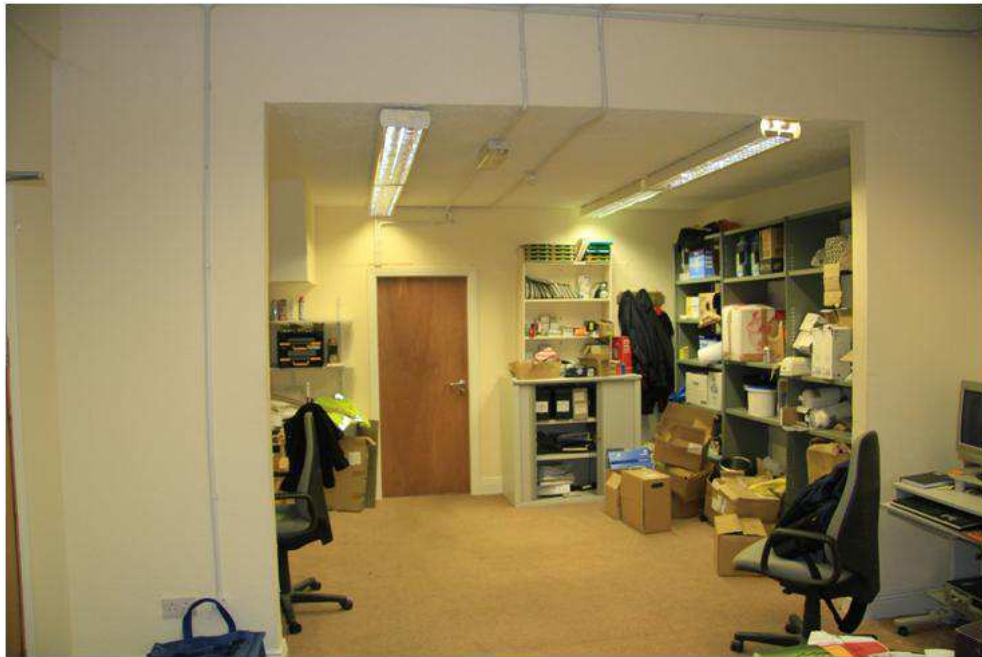
Plate 10: Ground floor of number 75, rear room seen from front

The ground floor of number 75 has been refurbished in recent years. There is no obvious sign of original features, with walls and window openings faced in recent plaster and painted. The ceiling to the front room appears to be replacement, while there is a suspended ceiling in the rear room. The doors are hollow doors of recent date, set in simple frames without architraves.

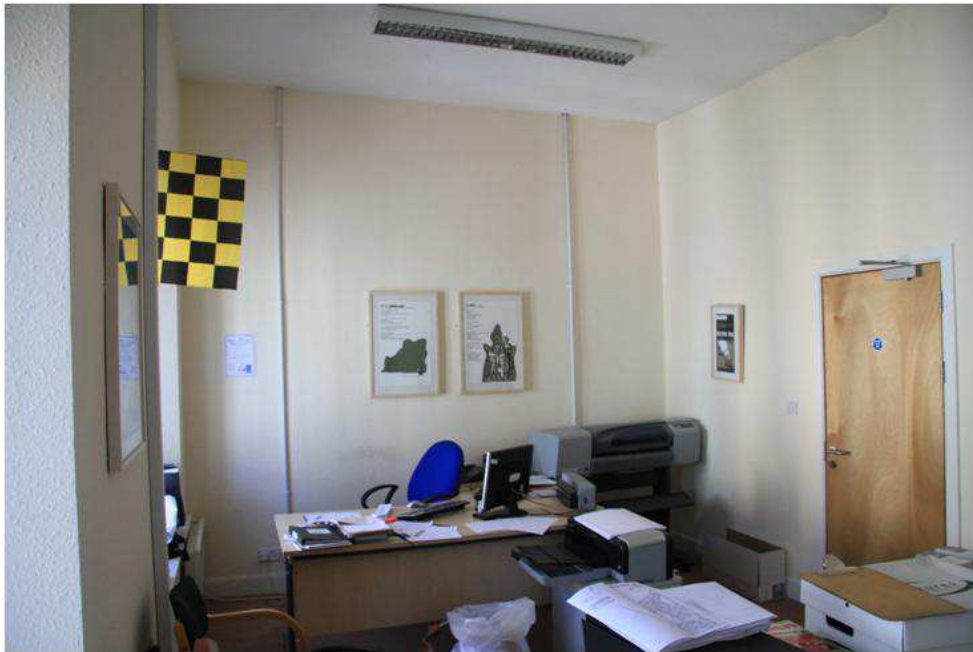
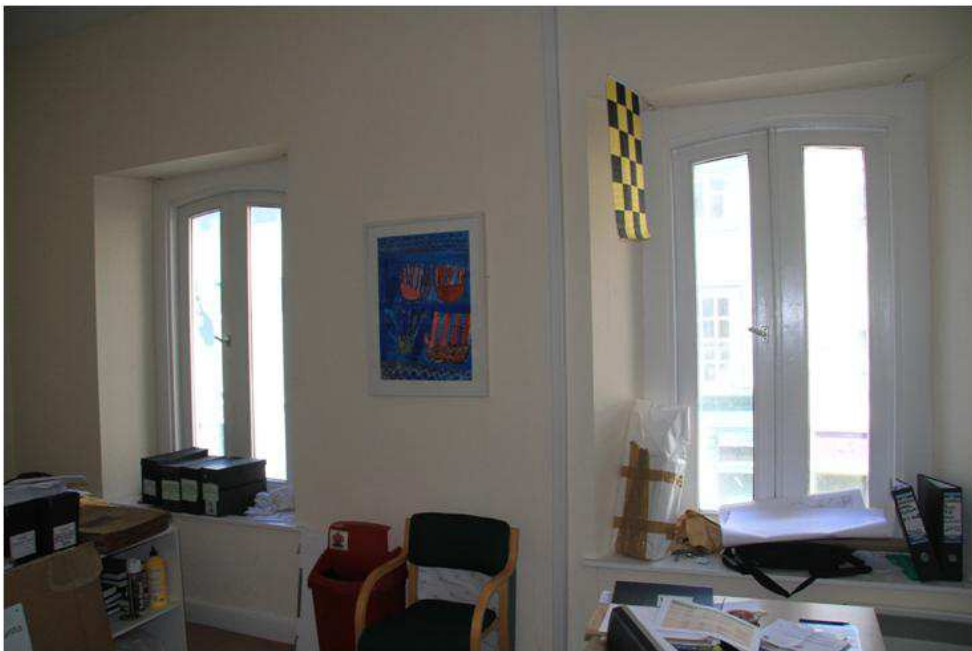
Plate 12: First floor front room in number 75

Plate 13: First floor front room in number 75

The front room on the first floor has been refurbished. The walls are newly plastered and painted. The windows are casements of recent date without linings or shutters. The door is a modern hollow door.

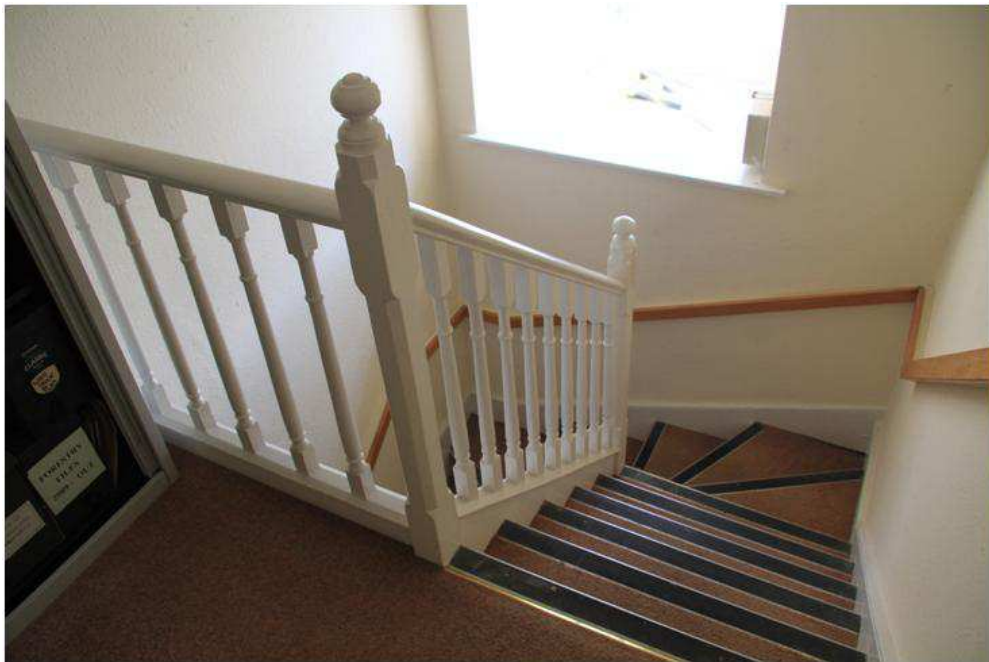
Plate 15 (below): Staircase

The staircase winds through twice so as to take up minimal space. The balustrade, spindles and newels are wrought timber and appear to date from the 1893 reconstruction of the building.

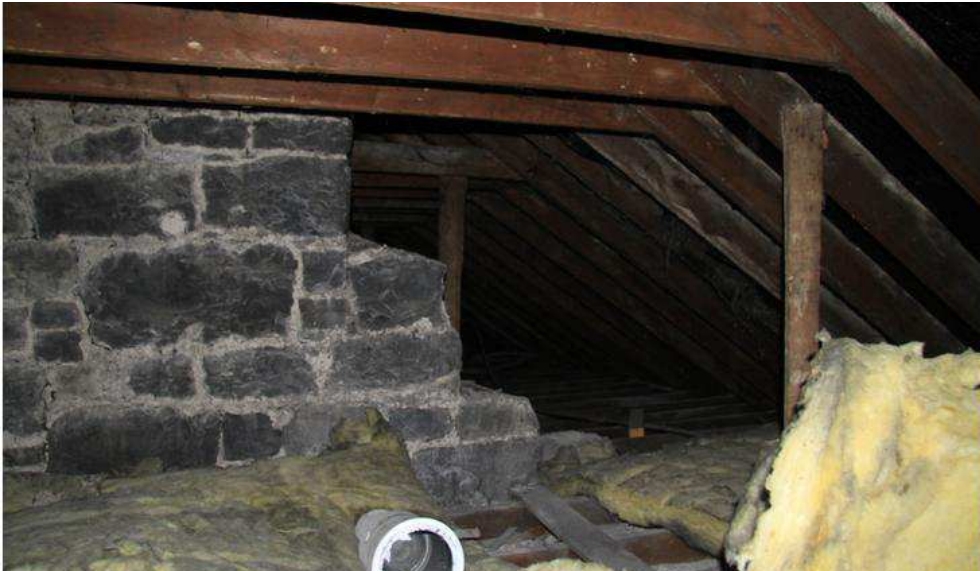
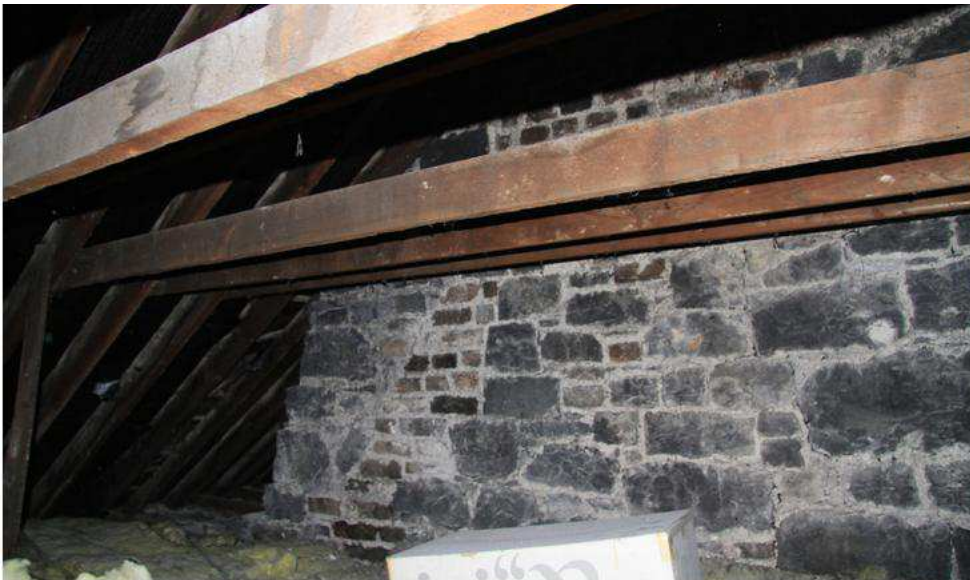
Plate 16: Party wall with number 74 at attic level – rear

Plate 17: Party wall with number 74 at attic level – front

The photographs above show the party wall with number 74 as seen at attic level. The upper photograph shows that the wall is stepped at the rear and stops well short of the eaves such that it would be possible to walk into the adjacent attic. In the lower photograph the same stepping is visible, but it has been evened out to a straight line with brick. A further addition to the wall in stone brings it out to another relatively straight slope, though this also does not reach the eaves, leaving a gap opening to the adjacent attic.

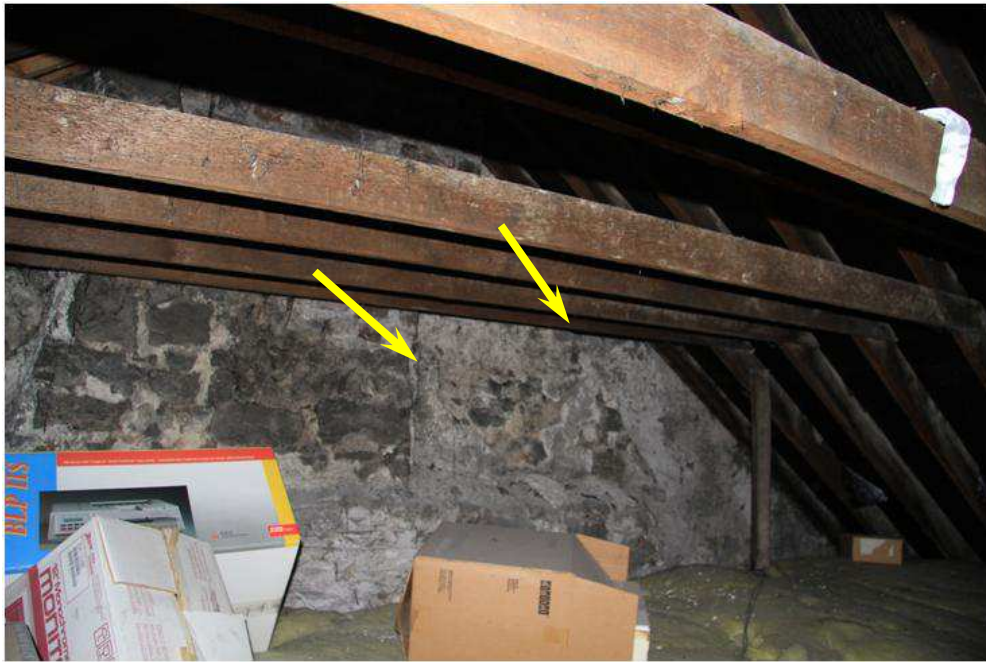
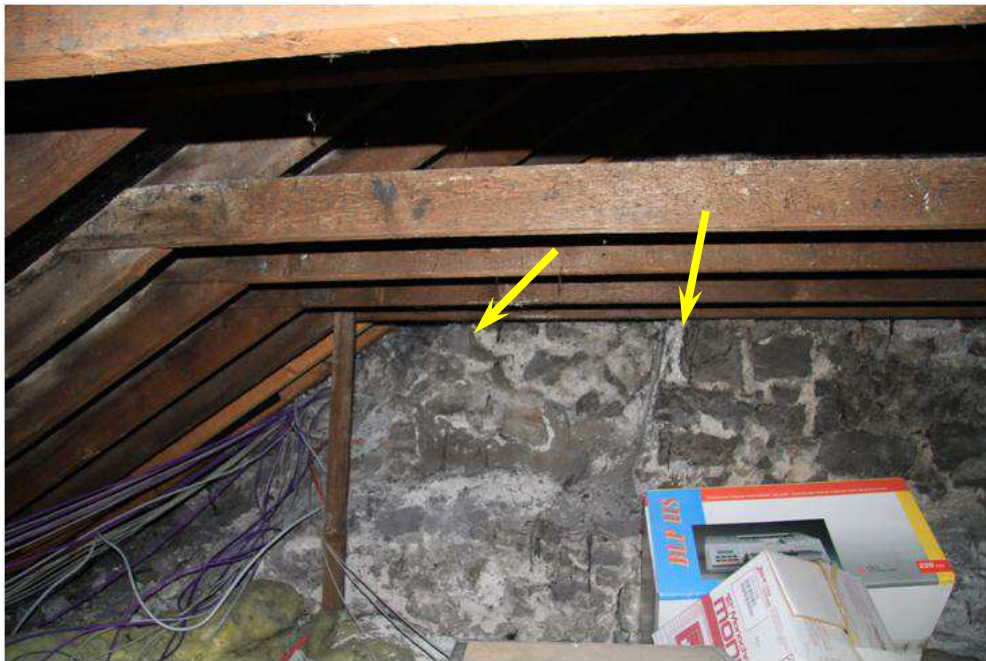
Plate 18: Party wall with number 76 at attic level - front

Plate 19: Party wall with number 76 at attic level – rear

The party wall with number 76 has been continued to the underside of the roof, leaving no significant gap. In the front section three phases of masonry may be seen, with two diagonal lines visible through the stonework. The location and orientation of these lines are indicated by the arrows in the upper photograph. Neither of these lines would have reached the present eaves. The vertical line at the left-hand arrow represents the line of the chimneybreast. The lines are less distinct on the rear section of the gable. They are marked by arrows in the lower photograph, the right-hand arrow showing the edge of the chimneybreast.

This is the same wall that was seen in the roof space of number 75, in plates 18 and 19 above, which showed that the other side of the wall had stone in the central section. The brick on this side would be consistent with a reconstruction date of the 1890s and the significance of the brick in such a location is that it was used to produce thinner walls in places where a flue passed through the thickness of the wall.

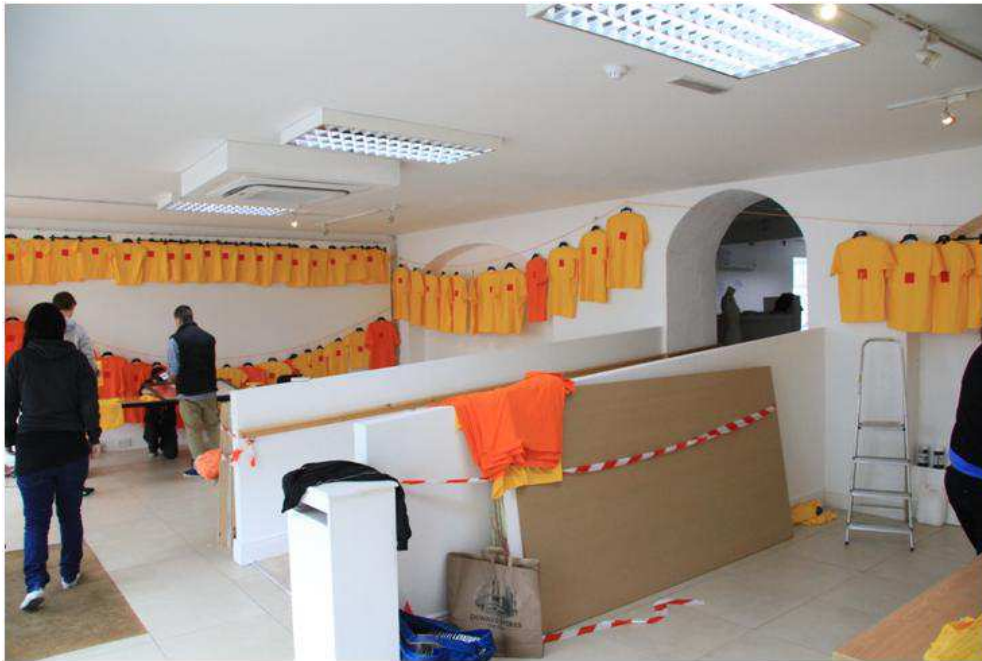
Plate 20: View to rear in shop unit

Within the shop area the walls, ceiling and floor have all been refurbished and no early features are visible with the possible exception of arches at the rear. A ramp climbs from the centre of the shop through an arch into the space to the rear and on either side of it are broad niches with segmental heads. These niches are infilled with stud walls of recent origin.

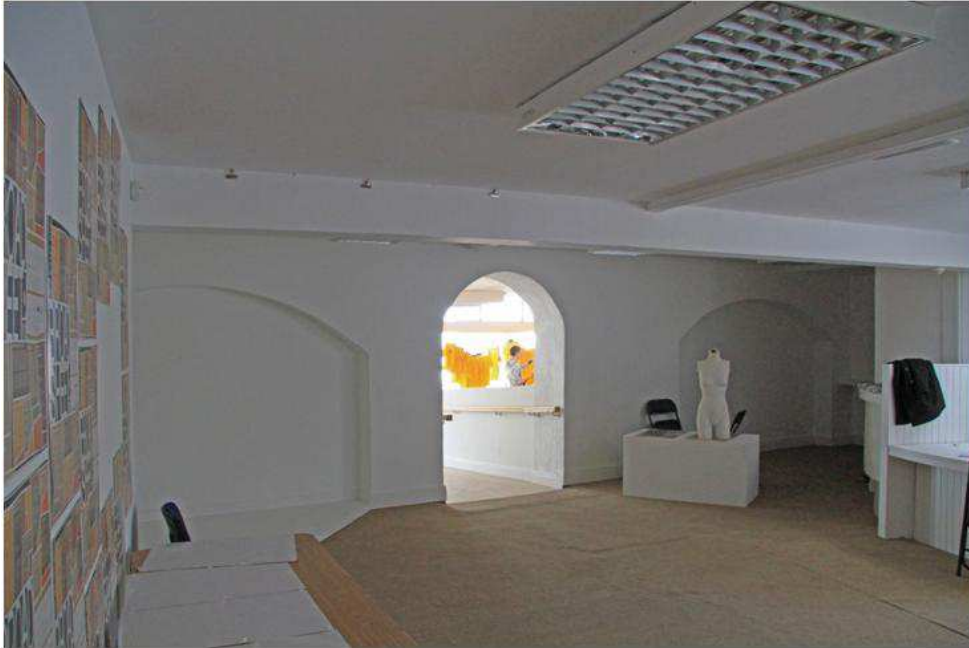
Plate 22: Rear wall of shop seen from within return

The arched niches are also expressed in the space at the rear of the shop unit, with the broad segmental arches of the niches and the narrower arch of the access ope. The space at the rear of the shop has recent wall facings, ceiling and floor. The rear wall of the extension at the rear of the shop is supported at ground floor level on a beam running across the return.

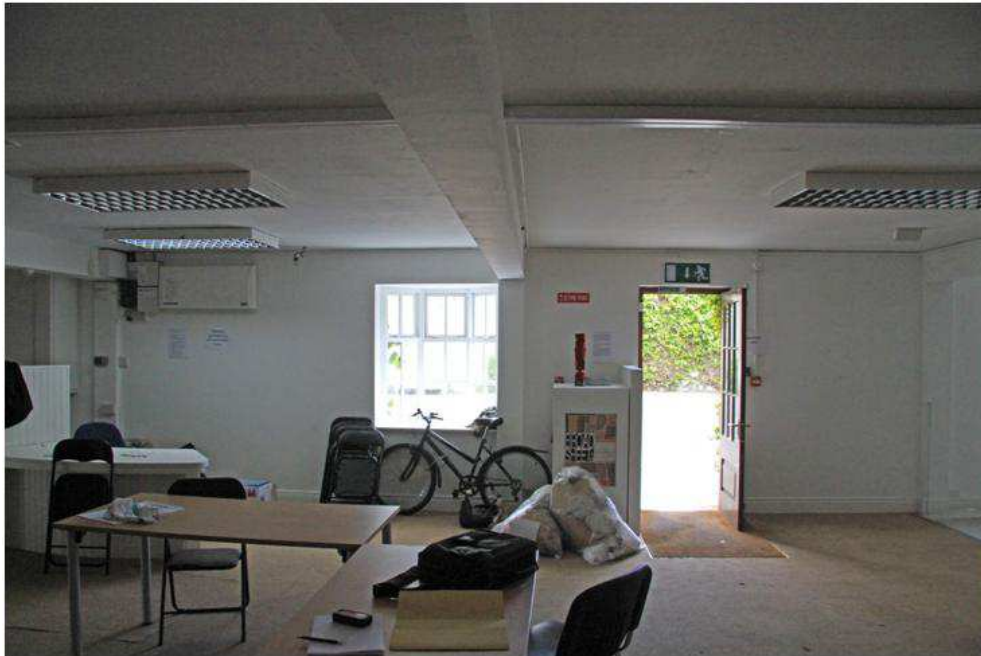
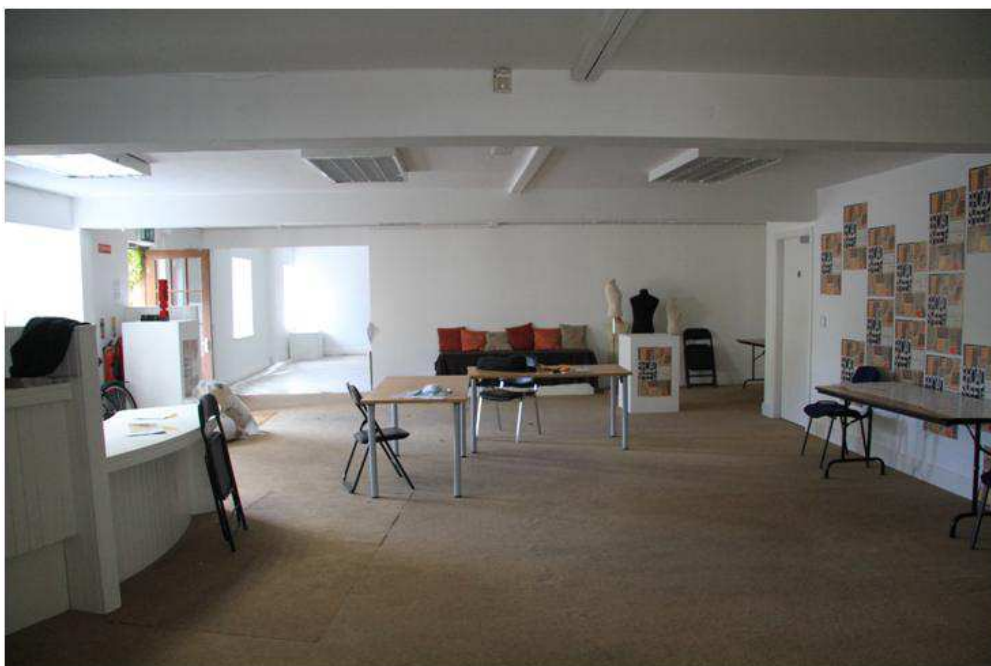
The interior of the return near to the shop is a broad area with a comparatively low ceiling supported on beams. An oriel window is of late twentieth century date, as is the door to the yard from the return. The side of the return adjacent to the property boundary is enclosed to carry the staircase to the upper floor.

Plate 24: View to side within the return

Plate 25: Interior of return seen from rear of shop

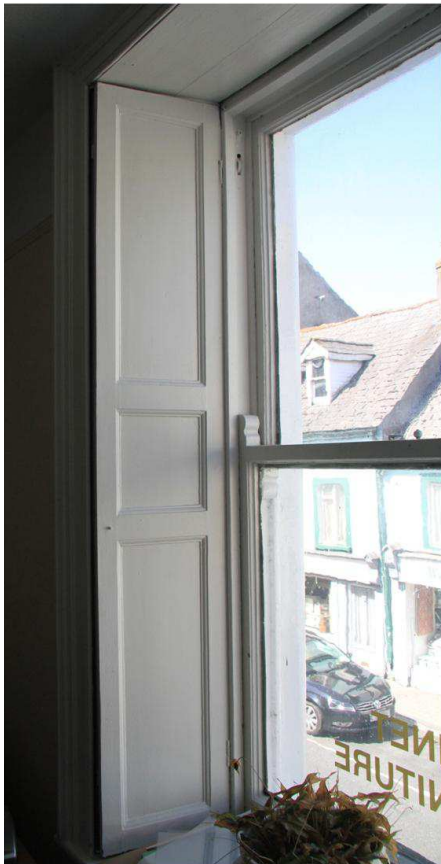
Plate 29: Detail of window at first floor level to front

The first floor windows to the front are one-over-one sliding sashes with horns. They have linings and architraves, with panelled shutters.

Some works would be carried out to the building at 76 John Street, other than the demolition of the substantial structure at the rear. This would include plastering the rear wall following the demolition and repairing the windows. Within the archway to the rear the surviving section of a fireplace from an earlier structure would be retained in place.

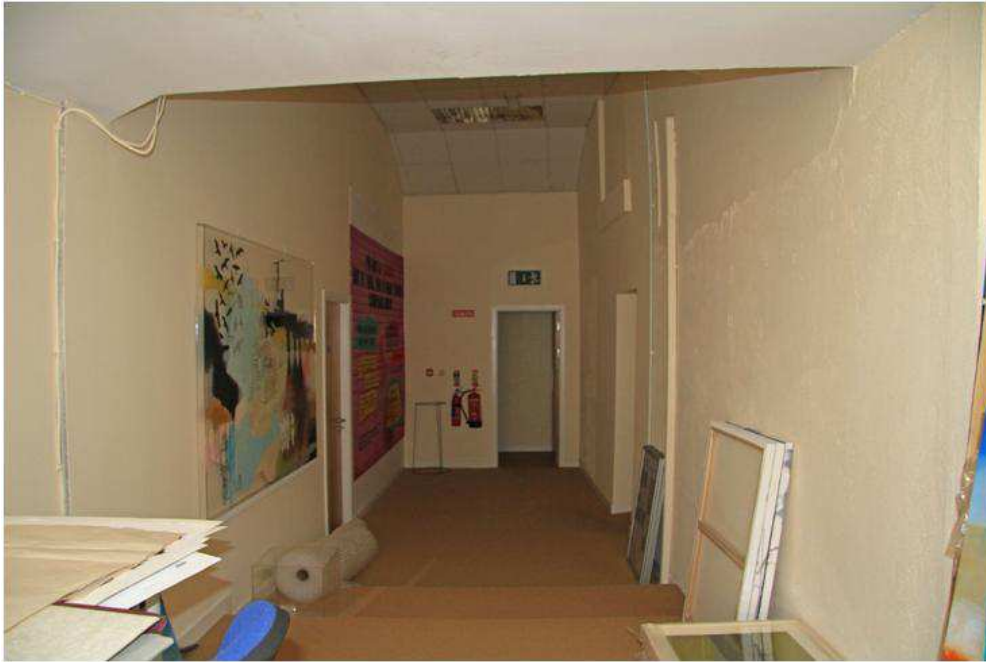
Plate 32: Corridor at rear of main building

As noted above, there is a corridor in the addition at the rear of the original building. The photograph below shows that there are alterations to the plaster on the wall at right, which is the original rear of the building. At high level in this corridor there is a blocked window with a substantial sill. The sill is painted, but appears to be of dressed limestone. There is a suspended ceiling in this area.

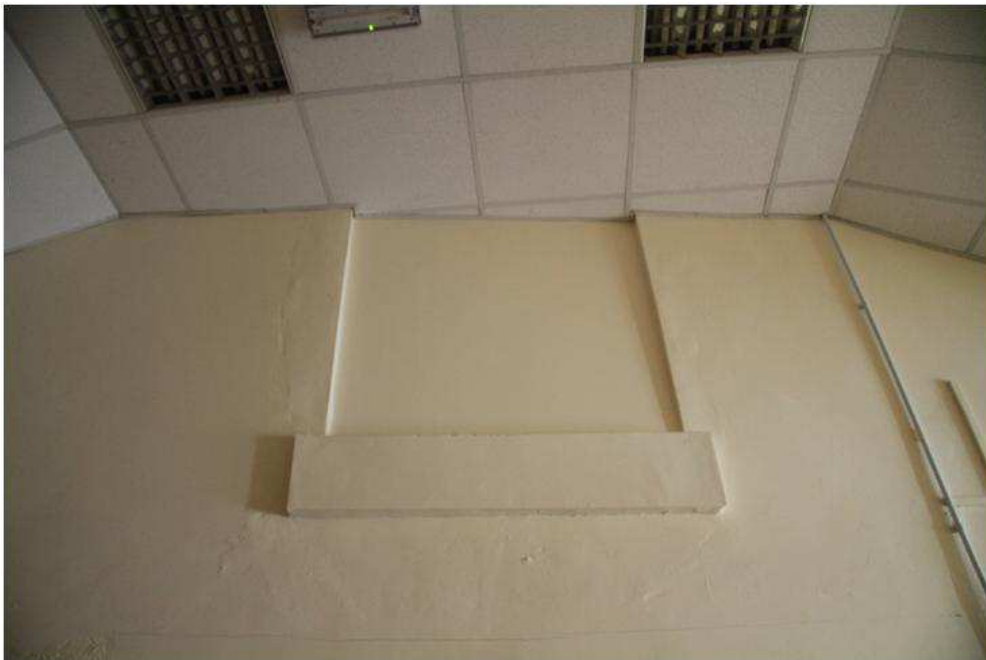
Plate 33: Blocked window in original rear wall of main building

In the rear office at the south-western end of the building there is a blocked window that projects partially into the roof area. This is the blocked window that was seen above the corridor and shown in plate 33 above. It would originally have been a lucarne window.

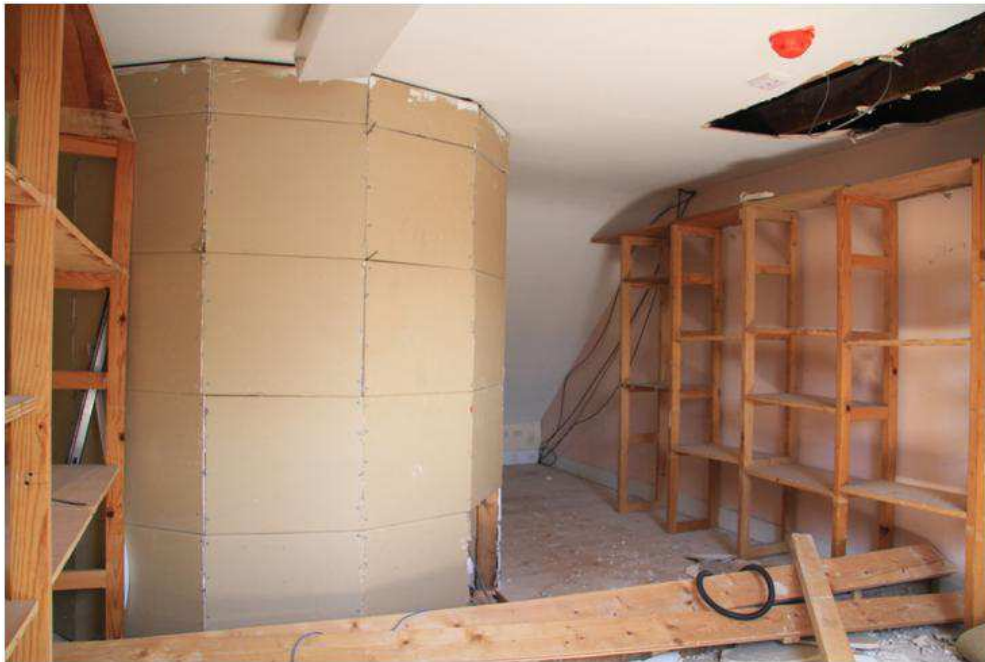
Plate 36: Space at attic level above passageway from street.

The attic space is divided by the masonry wall that rises between the passageway and the main building. The rest of the space is divided by recent stud and slab partitions. This floor is fitted out as offices, but decommissioned with the former spiral staircase removed for health and safety reasons. The partitioning of this former staircase is visible at left in the photograph below.

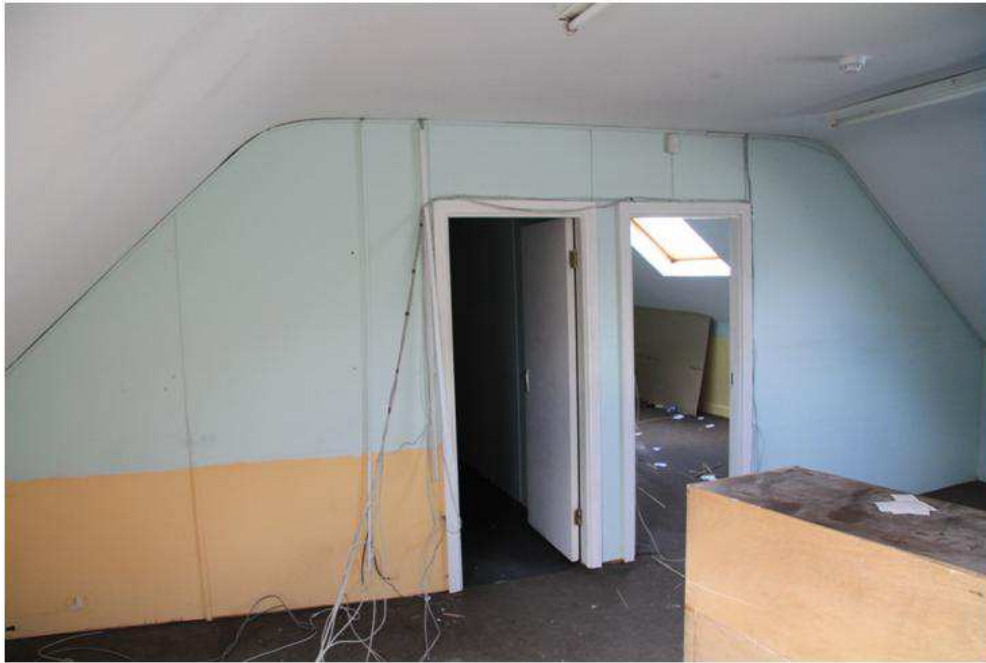
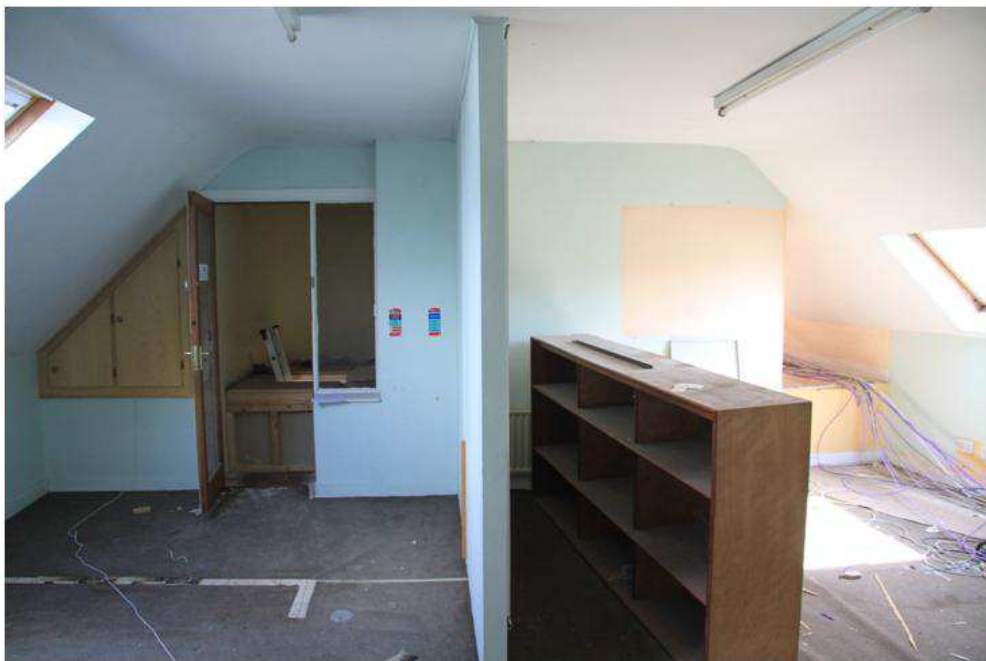
The divisions and doorways in the central space of the attic floor are seen in the photographs below. The upper photograph shows the doors to the two rooms at the south-western end of the building. The ceiling and walls are of plasterboard. There are late twentieth century rooflights illuminating this space.

Plate 37: Doors to adjacent rooms in attic area

Plate 38: Offices in central area of attic space

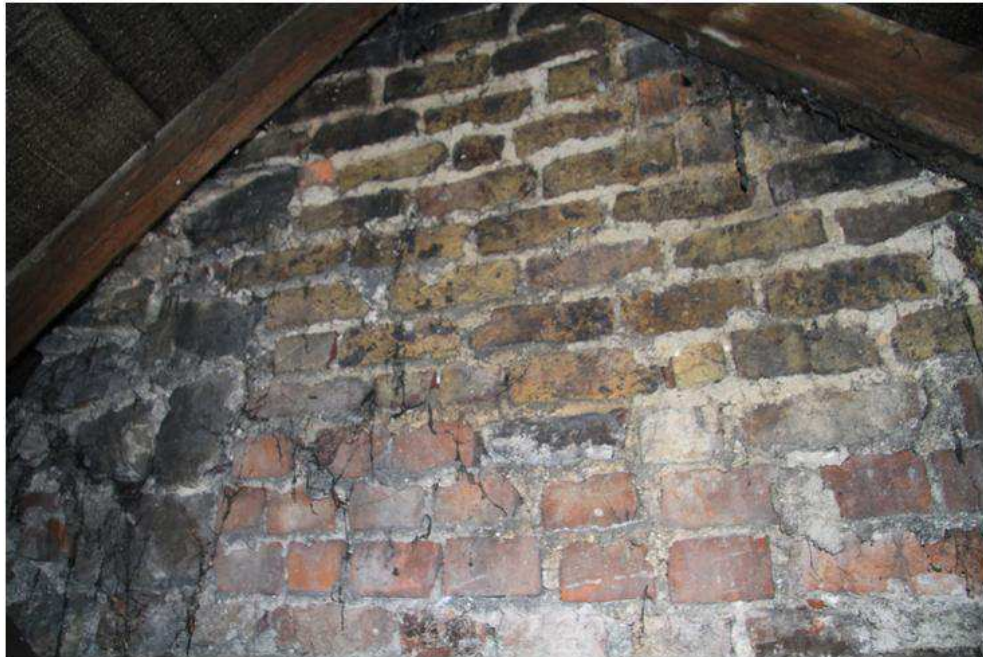
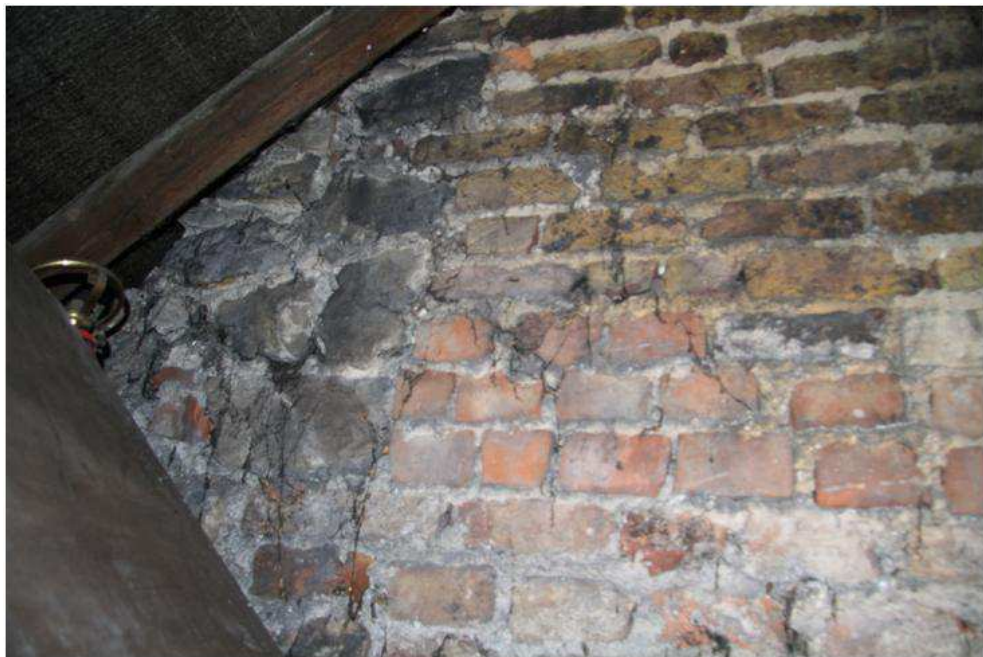
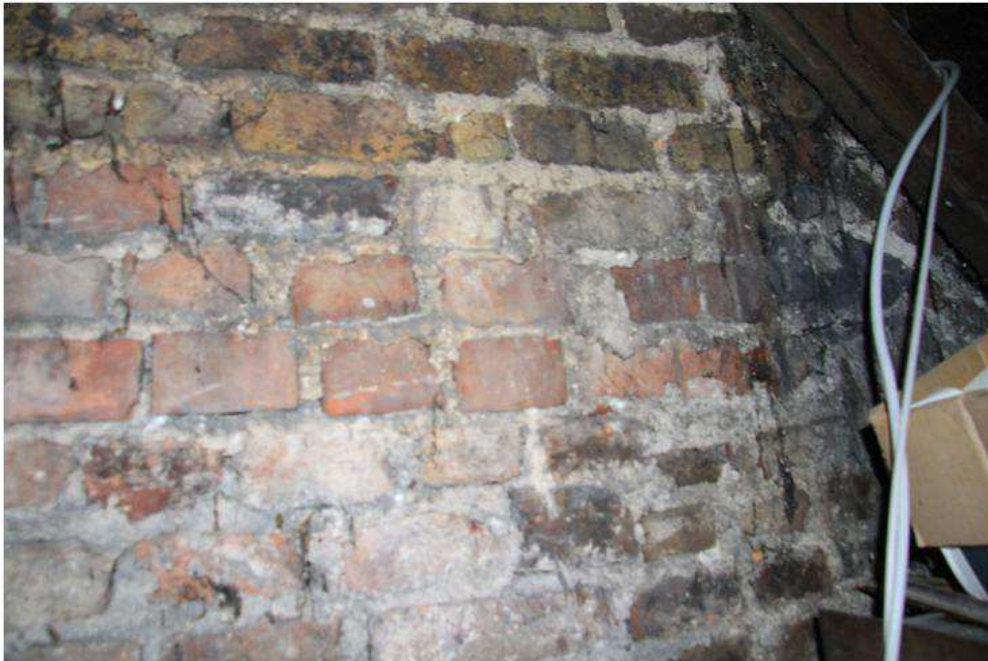
Within the small area of roof above the attic offices the party wall between number 76 and number 75 may be seen. This has a central section of brick, flanked by rubble limestone walling. The brick section has lower courses in a red brick, mainly viewed as headers, while the upper section is a yellow brick, predominantly of stretchers. The junction with the stonework is irregular.

Plate 41: Central section at top of party wall between numbers 76 and 75

Plate 42: Front section of party wall between numbers 76 and 75

Plate 43: Rear section of party wall between numbers 76 and 75

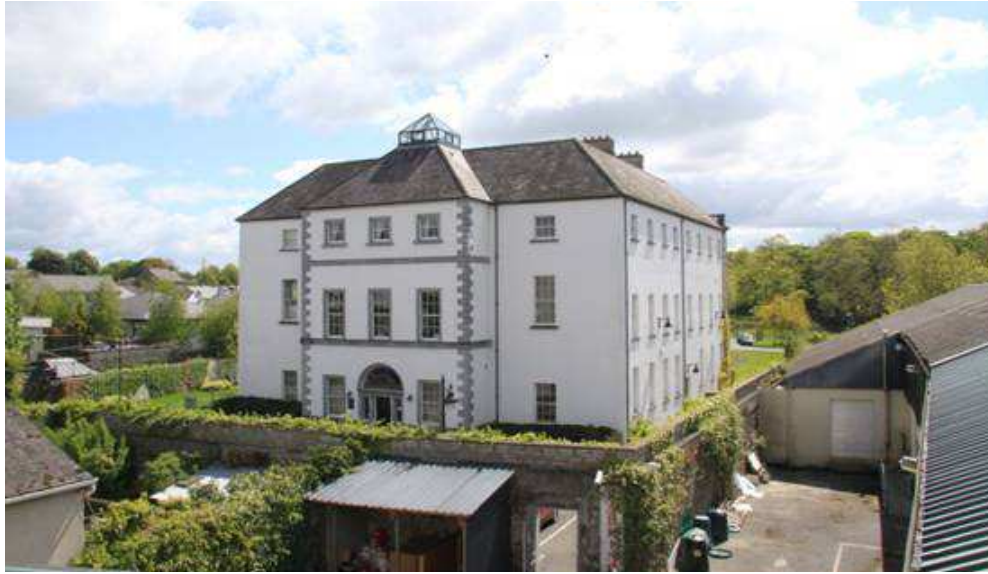
Plate 44: Entrance front of County Hall

County Hall is a substantial three-storey Georgian building standing in its own grounds to the east of John Street. The entrance front, seen above, faces north-west and has a large three-bay breakfront in the centre, flanked by single bays. The central section has dressed limestone quoins, string courses at first and second floor level and framing to the windows. The walls that flank this central section are plain. In the centre of the ground floor there is a substantial Georgian-style doorway with a large semicircular fanlight, below which the doorway is flanked by dressed limestone piers and with sidelights. The windows are timber sliding sashes, predominantly six-over-six, but with some variants. The roof is hipped and slated, without a parapet, and there is a lantern crowning the roof over the central breakfront.

The south-western elevation, seen at right in the above photograph, is three-storey, with the storeys on the first floor at a lower level to those on the entrance front. This elevation is plain, without the prominent limestone dressings that are seen on the north-western elevation. This side of the building is relatively close to the boundary of the property, which is marked with a high wall of stone and concrete, described above. The building at the rear of number 76 John Street runs back as far as County Hall, and projects to the boundary, as seen in the photograph above.

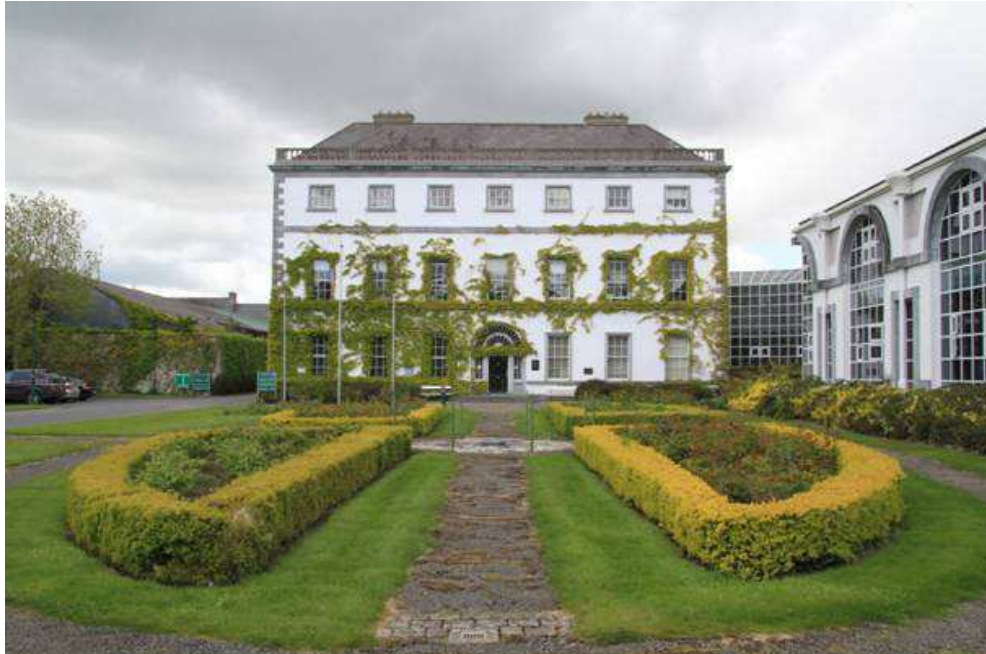
Plate 45: Garden front of County Hall

The garden front of County Hall is three-storey and seven-bay and faces south-east. The facade has dressed limestone quoins, framing to the windows and string courses at first and second floor levels. In the centre of the ground floor is a Georgian-style door that is a main feature of the facade, with a substantial decorative semicircular fanlight, a panelled door flanked by decorative sidelights and with dressed limestone piers flanking the door and sidelights. At roof level there is a stone balustrade surmounting a parapet, behind which the slated hipped roof rises.
